Review Paper

Geological Investigation of 5.6 M_w Mirpur Earthquake, Northwestern Himalayas, Pakistan

Keywords: Mirpur earthquake, Western Himalaya, Surface Rupture, Seismo-tectonics, Samwal Fault.

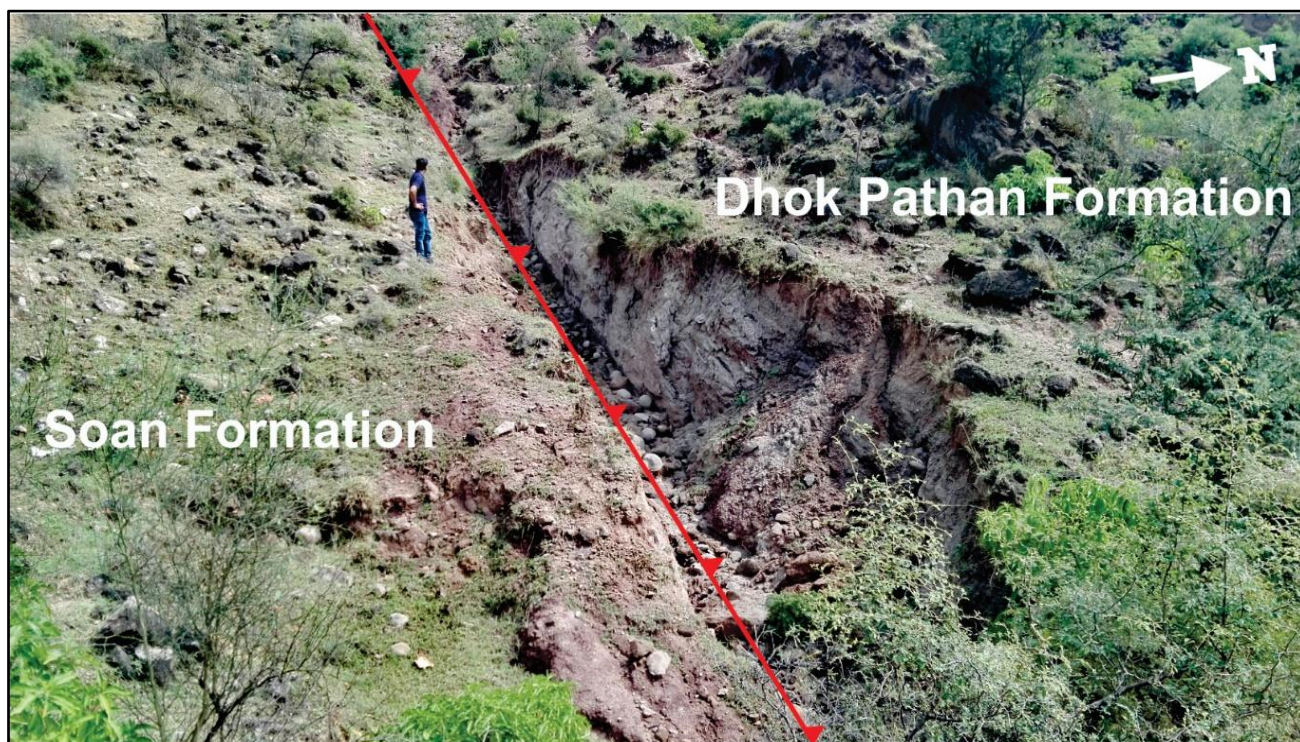
A major fault trace was exposed near the Samwal Village. This rupture lies on the faulted contact between Dhok Pathan and Soan formations (Figure-7). However, a crack opening was calculated 01 m at maximum point, whereas, the evidences of slip sense (i.e. slicken slides) were not clear because of heavy rainfall occurred after the main shock. Many other small-scale cracks and opening were encountered along the fault line with frequent landslide phenomena (Figure-8).

Figure-7: Field photograph showing the faulted contact between Dhok Pathan and Soan formations near Samwal Village, while this red line indicating the possible fault plane along which ME of 2019 occurred.

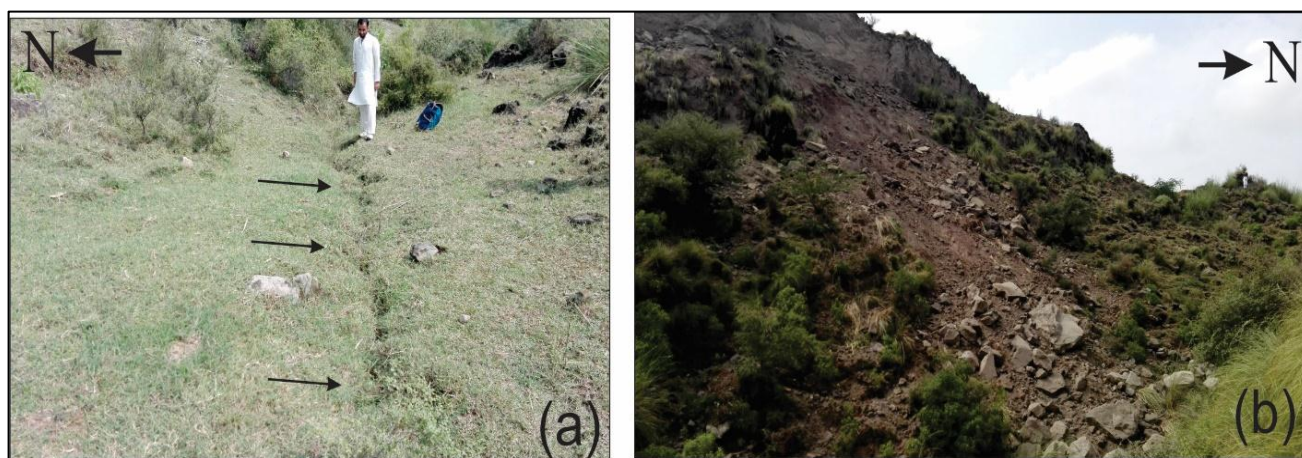
Figure-8: A field photograph (a) illustrating a minor rupture of about 6" width associated with the Samwal Fault while (b) showing land sliding along the fault line in the study area.

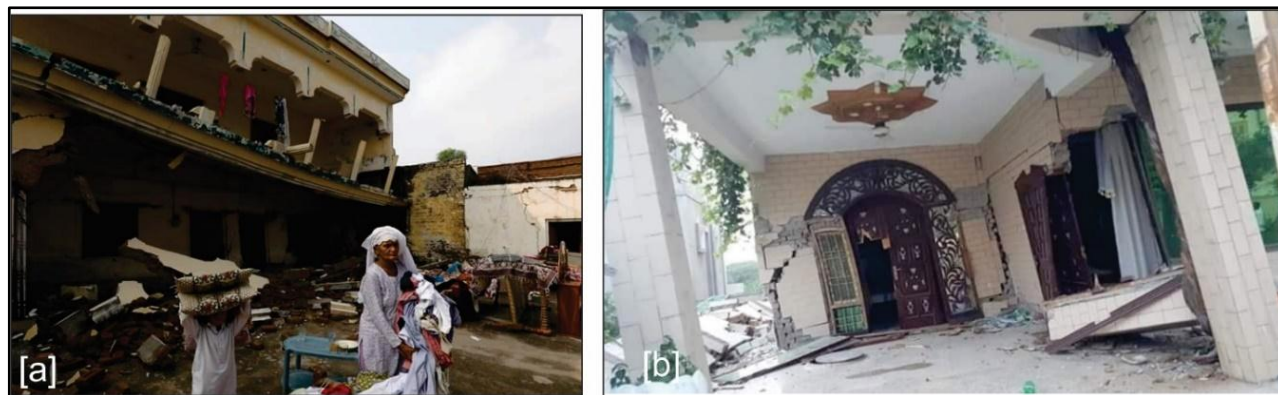
Infrastructure damaged: The earthquake has caused a number of human fatalities due to crumbling of buildings, because they are lacking of proper foundations and selection of poor construction materials i.e. aggregate, cement, sand, water, steel, and admixture or their proper combination (concrete-mix-design). As a consequence of this, buildings did not withstand against the lateral earthquake forces. Most of the earthquake-prone developing countries including Pakistan are facing such sort of serious problems. These problems are becoming diverse because of population expansion, financial insecurities, insufficient stock of wood, steel, cementing material, and poor knowledge of earthquake characteristics etc.

Infrastructures built on unconsolidated materials are quite disturbed near the epicenter of earthquake. Failure of buildings are owing to poor selection of construction materials and ignoring foundation's importance to withstand superstructure. Infrastructure is more disturbed nearby the proximity of the water bodies (Figure-9, Figure-10).

Figure-9: Field photographs (a) and (b) showing a collapsed house due to ground shaking at Jatlan and Samwal villages, respectively.

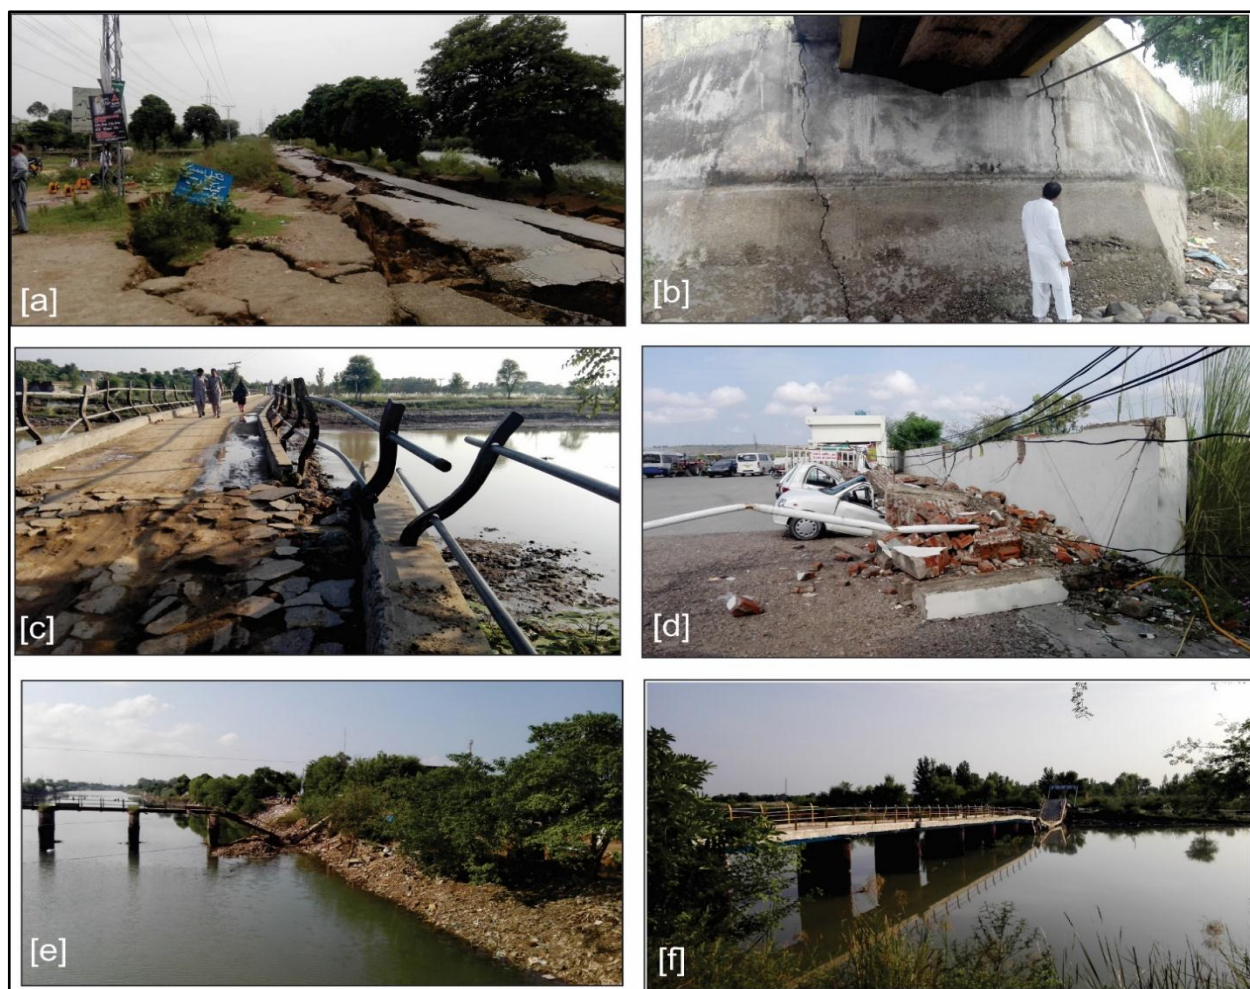
in plan and elevation. In addition to this, cracks and fissures were turned up on buildings wall, floor and on the roof are the main factors responsible for damages. ii. The failure observed in the foundation is mainly initiated as a result of liquefaction induced by lateral spreading of loose soil, ground water pockets or soil settling due to ground shaking. iii. The poor understandings of reliability in structural components are one of the major reasons of damage. Greater thickness of the roof's slab exceeding the standard specifications acted as a catalyst to fall down during the adverse event of earthquake. iv. Faulty construction materials with inadequate skilled labor in structure building, etc. resulted in infrastructure failure.

Figure-10: Field photographs showing (a) the liquefaction induced lateral spreading along the embankment of UJC (b) cracks in abutment of Dab Bridge (c) vehicle damaged by the collapse of boundary wall (g) Manda Bridge collapse (e) the Bani Bridge after earthquake (f) the displacement of abutment of Sang Bridge.
