# Geophysical and Geotechnical Investigation of Cham Failed Dam Project, Ne Nigeria

Caleb Adwangashi Tabwassah and Gabriel Ike Obiefuna

Department of Geology Federal University of Technology, Yola, NIGERIA

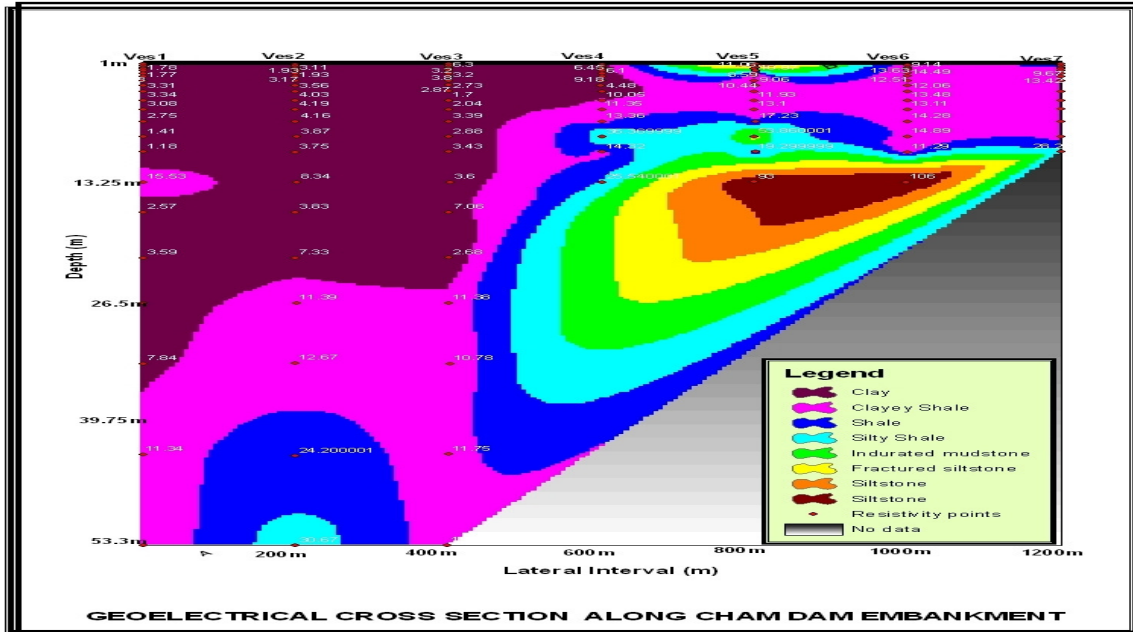
Figure-3  
 Geoelectrical Crosssection along Cham Dam Embankment

From the above geo-electrical section of proposed cham dam axis, it is observed that the top lateritic soil is averagely 4m thick around VES 01 and approximately 8m at VES 07. This is immediately underlain by shale to shally clay at the depth of 4m from the topsoil and thickens averagely 40m along VES 01 – 03. At VES 03 – 05 is a patched bed of calcareous siltstone or marl, immediately underlying the topsoil at 11m depths to the center of the dam axis. The siltstone bed thins out at the east and western part of the dam axis.

At VES 07 is a thick layer of claystone (mudstone) it occurs at 9m depth and thickens 8m, and is immediately underlain by shally clay. At VES 06 is a thick layer of siltstone which occurs at 15m depth, and thickens averagely 30m. At VES 01 the siltstone layer outcrops at 45m depth, while in VES 02 it outcrops at depth 33m, and at VES 03 – 05 it outcrops at depth 22m.

**Major Displacements:** The major displacements are observed at depth 48m in VES 01, 45m at VES 02 and between VES 02 and 03 at 25m depth, others occurs between VES 06 and 07 at depth 53m down the subsurface. Table 2 is a summary of events on the geoelectrical section of proposed Cham dam axis.

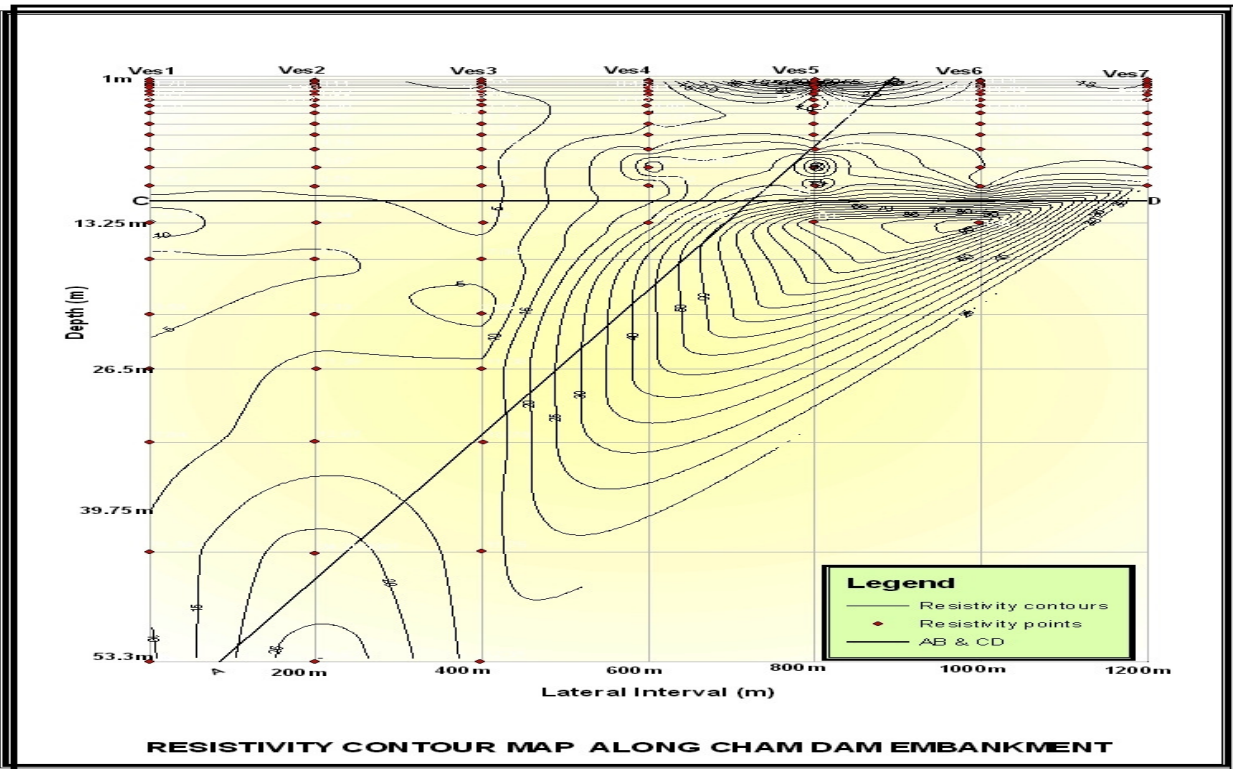
**Figure-5**  
Resistivity Contour Map along Cham Dam Embankment

the resistivity contour map along Cham dam embankment and subsurface resistivity profile along dam embankment respectively. The resistivity contour map covers a total horizontal distance of about 1200m. The former shows the cross section of rocks along the embankment. The area is underlain by shally clay and top soil to an average depth of 35m, and a siltstone bed extend to an unknown depth around VES 1, this is approximately similar to those of VES 2 and 3, while VES 4, is an array of chronologic lateritic dark clay to friable shale which extend to about 35m (figures 7, 8, 9 and 10). This is immediately underlain by probable silty shale to muddy shale to an unknown depth below. VES 5 (800m) is characterized by abrupt high resistivity which indicates that siltstone out crops from about 50m to about 1.5m to the surface (figure 11). This point is characterized by abrupt fall in resistivity between the depths of 10-25m; this represents a probable displacement (fault).

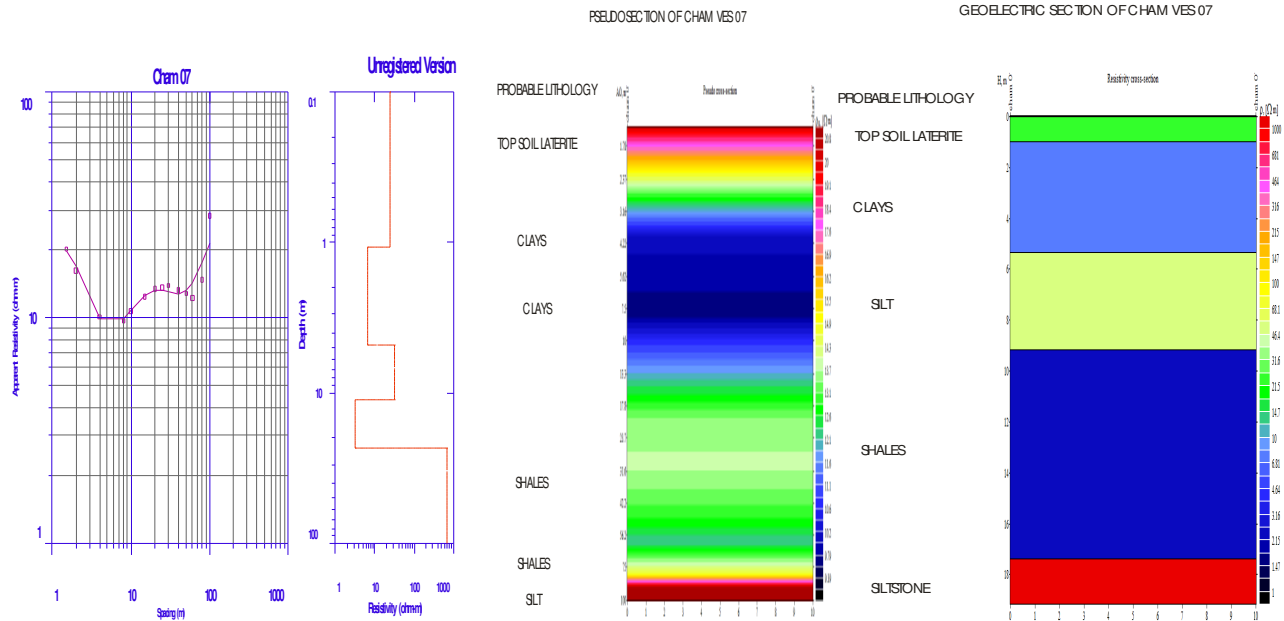
**Figure-12**  
**Resistivity Curve, Pseudo section and Goelectrical Section of VES 06**

VES 6 is characterized by shallow beds of siltstone at 1.5m to 45m, this is however cross cut by a minor fault between depths 35-45m (figure 12). The resistivity contour map of the same area from which the profile of the study area was plotted clearly indicates displacement at depth 39.75m along VES 3 and at about 7-10m depth along VES 4 to VES 7 (figure 5). It shows that the western part of the studied area with reference to the starting point is underlain by high resistivity rocks at shallow depth of 1-40m. The shape of this resistivity curves is related to the subsurface geology the entire surveyed area.

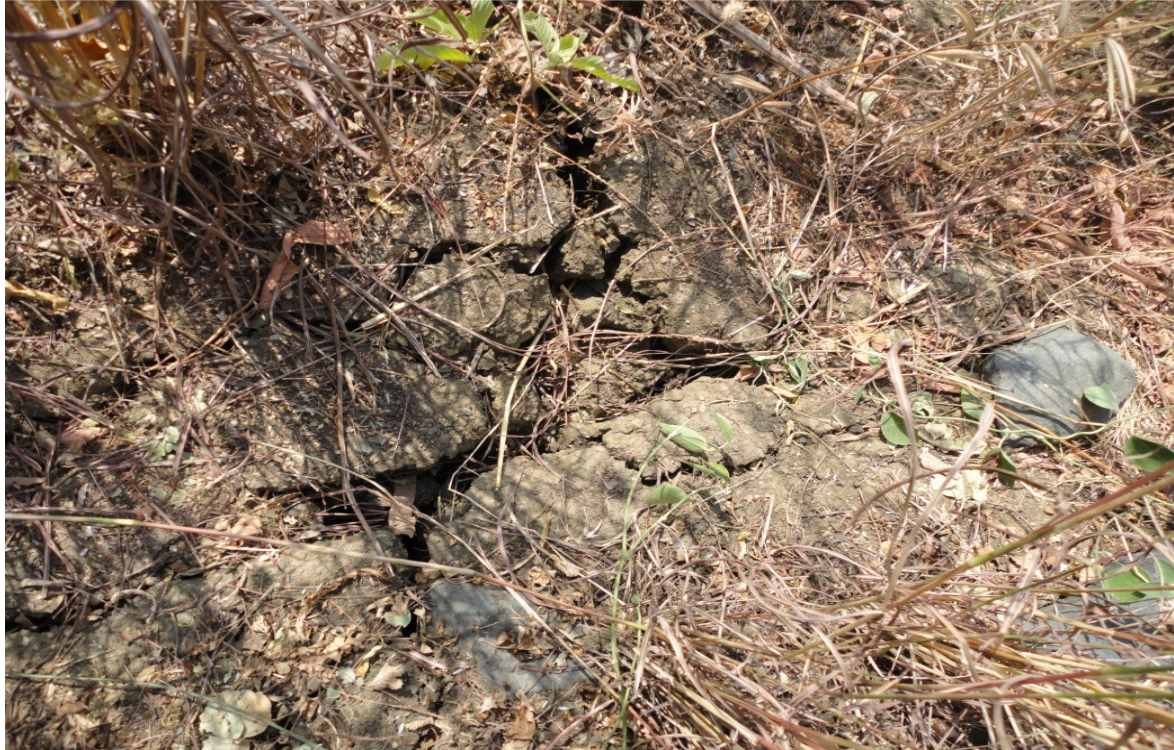
**Plate-3**  
Shows Desiccated cracks within the reservoir area

**Desiccated cracks:** These were observed as polygonal or linear fractures in weathered sediments of darkish grey shale or dark mud within the entire dam site, they occur as partings or openings in the bulk surface of the underlying rocks of the reservoir area. They are potential points of water lost (leakages). Examination of these features revealed a polygonal shape showing that it is structurally controlled (see plate 3).

erosion causing minor fractures to open. This also could be due to stress or increase hydraulic head acting in this area and also due tectonic tensional forces. The faulting of the calcareous siltstone at the river bed is tectonically controlled, because of its N-S orientation. This is connected with the famous N-S tensional tectonic deformation of the Yola-arm of the upper Benue Trough, during the emplacement of the Cameroon Volcanic Line. These are common around the southwestern part of the dam around the reservoir (plate 3).

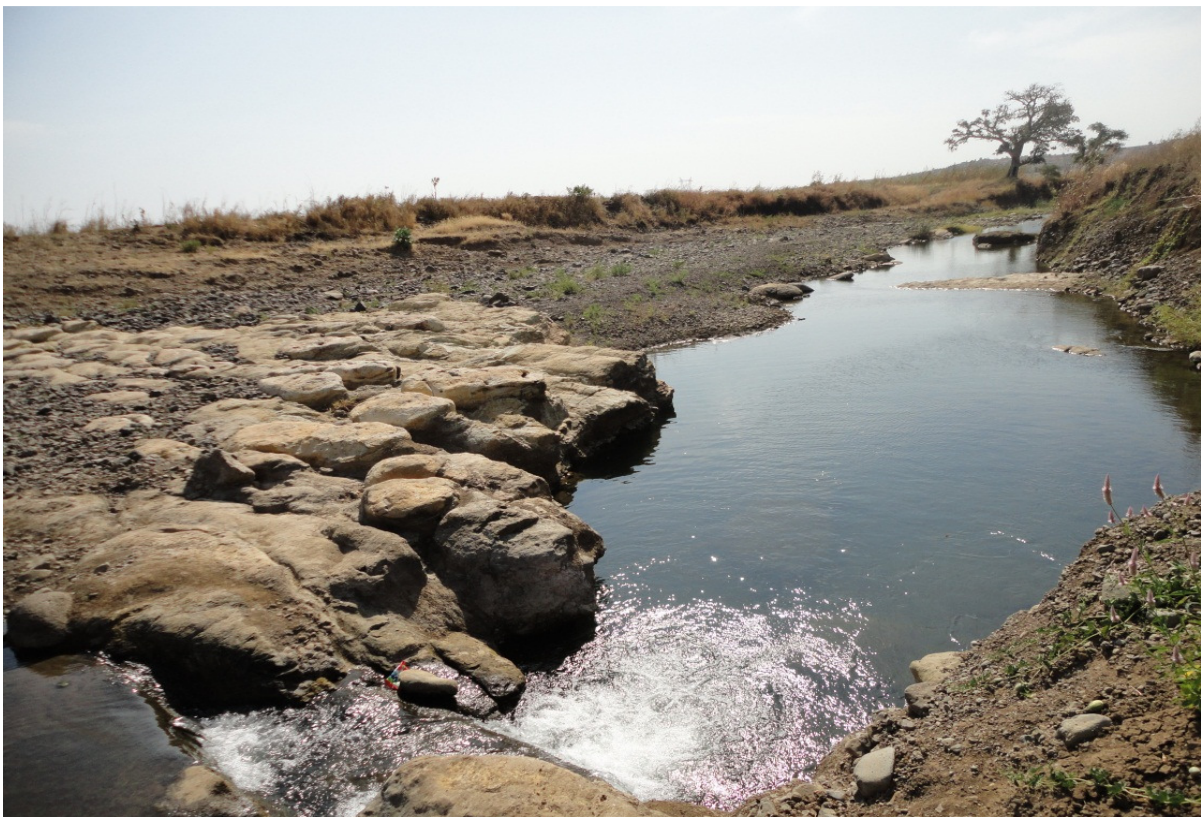
**Plate-4**  
Shows joints within the reservoir area

**Geotechnical Evaluation:** The study area covers some parts of Cham in Balanga Local Government Area of Gombe State. It is underlain by rocks of Yolde and Jessu Formations of the Yola arm of the Benue Sedimentary Basin. Geotechnical investigations of soils from the proposed dam sites on the basis of Atterberg limit, particle size and compaction tests were carried out to assess the geopedologic and hydrologic conditions. As would be seen on laboratory test report below post-depositional structures observed during investigation of the dam foundation include: desiccated cracks, joint, faults and potential land slide areas (see plates 3, 4 and 5).

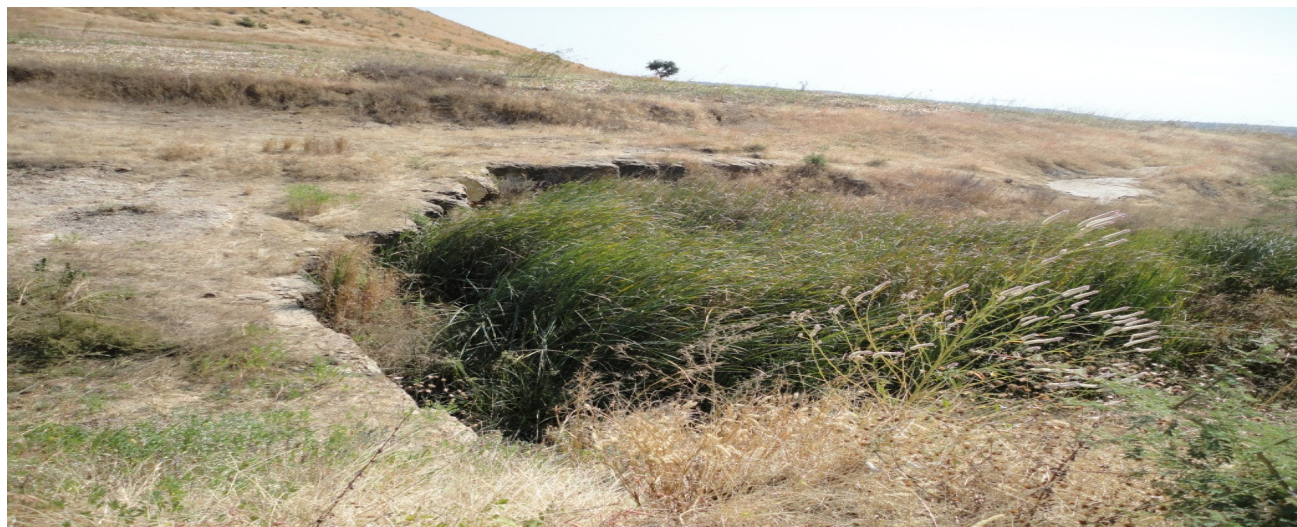
**Plate-5**  
 Shows fault plain along the proposed spillway area

The above figure is an exposed cross-section of the underlying beds and structures along a river channel within the dam area, it could form an average representation of the studied area along the embankment. From the figure above, it could be deduced that, shally clay overlies siltstone to a depth of 35m at point 00, 39m at point 200m, 13m at point 600m, 45m at faults: These are also planar discontinuities observed along the floor of the reservoir area west ward and along the spillway (table 1). These result from offloading by

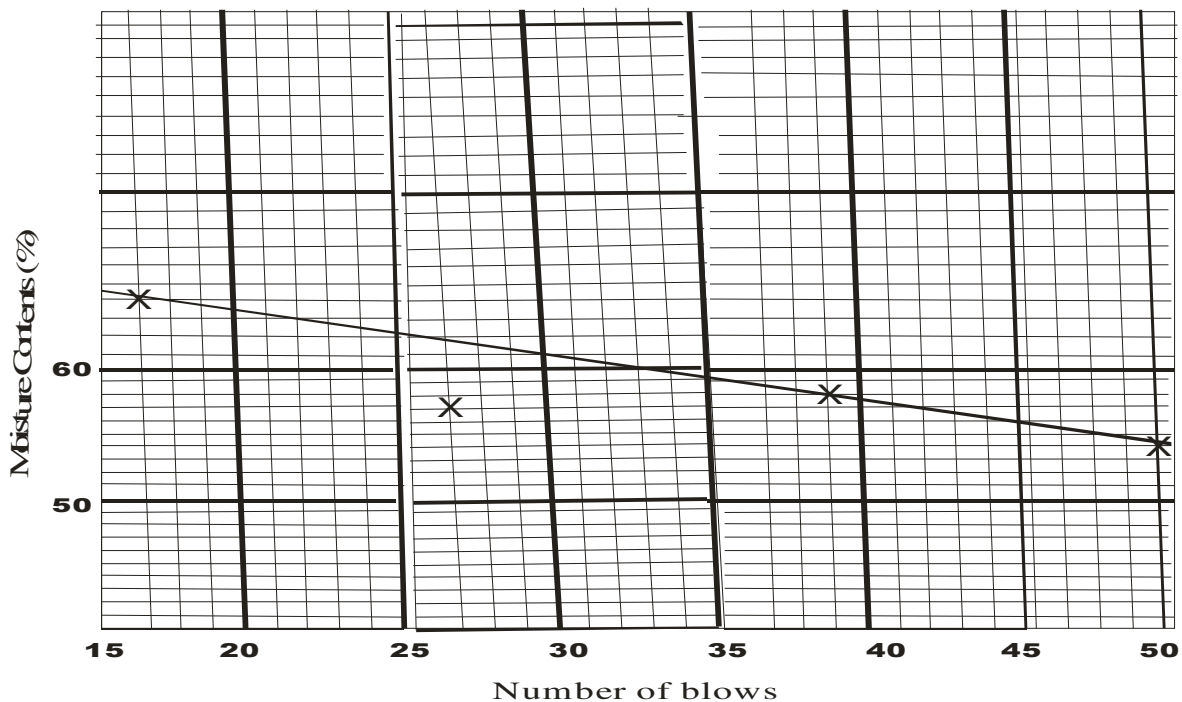
**Figure-13**  
**Plot of Liquid Limit Test of Cham Dam Site**

**Liquid Limit:** The liquid limit of the sampled soil is 60% which is relatively high in relation to the specified 35% by Clayton and Jukes<sup>7</sup>, (see table 6) this in turn implies high plasticity (figure 13).

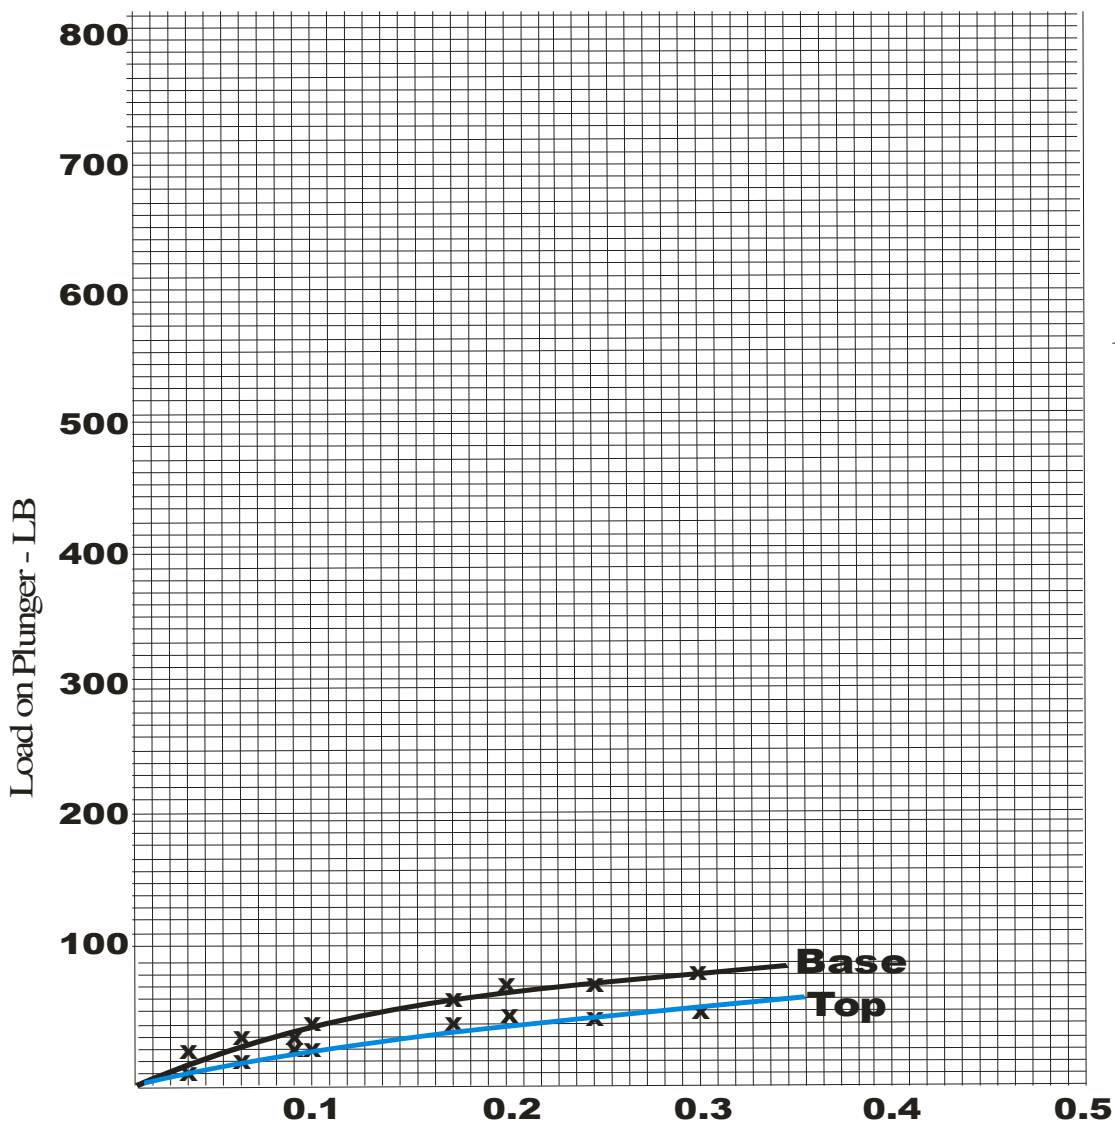
**Figure-14**  
**Plot of C.B.R. Test of Cham Dam Site**

**California Bearing Ratio:** From the result of the CBR test indicates that they are generally below the standard value of 10% for sub-grade materials (table 4 and figure 14) . From the average results of both CBR and Atterberg limit tests, the soils are cohesive. It thus indicates that the soils are susceptible to cracking and fracturing.

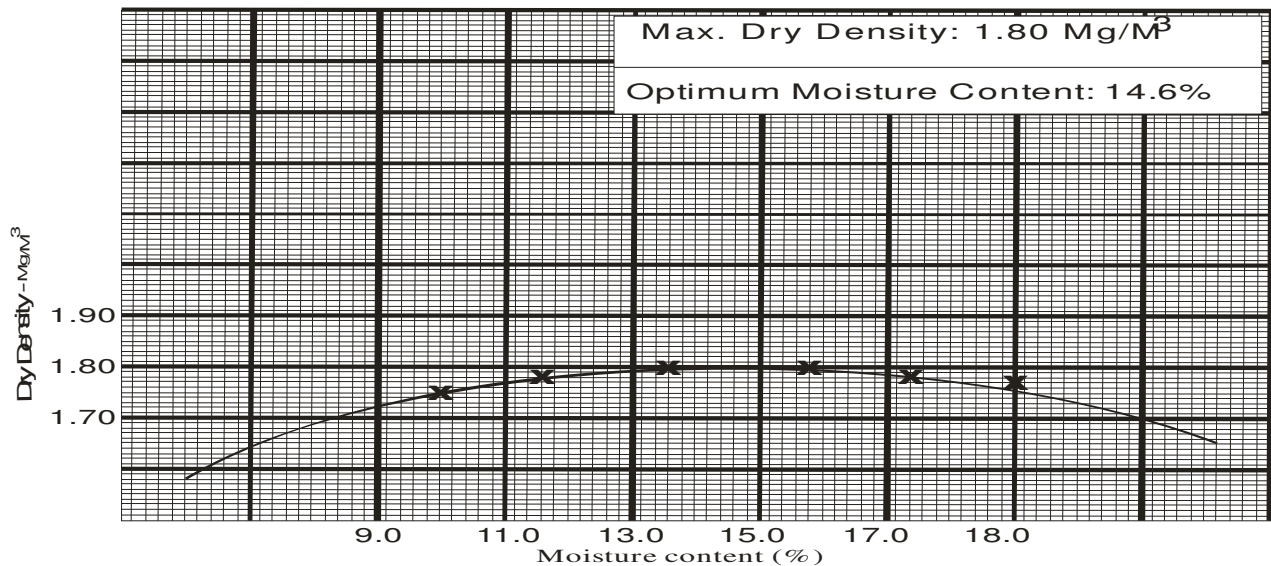
**Figure-15**  
**Plot of Compaction Curve of Cham Dam Site**

**Maximum Dry Density (MDD):** The standard value for maximum dry density, ranges from 0.76-1.11 and the MDD of sampled soil is 1.80 (table 5). This is slightly above the specified range<sup>8</sup> which means that the soil is highly compactable, and could attain the dense strength as a required embankment material (figure 15).

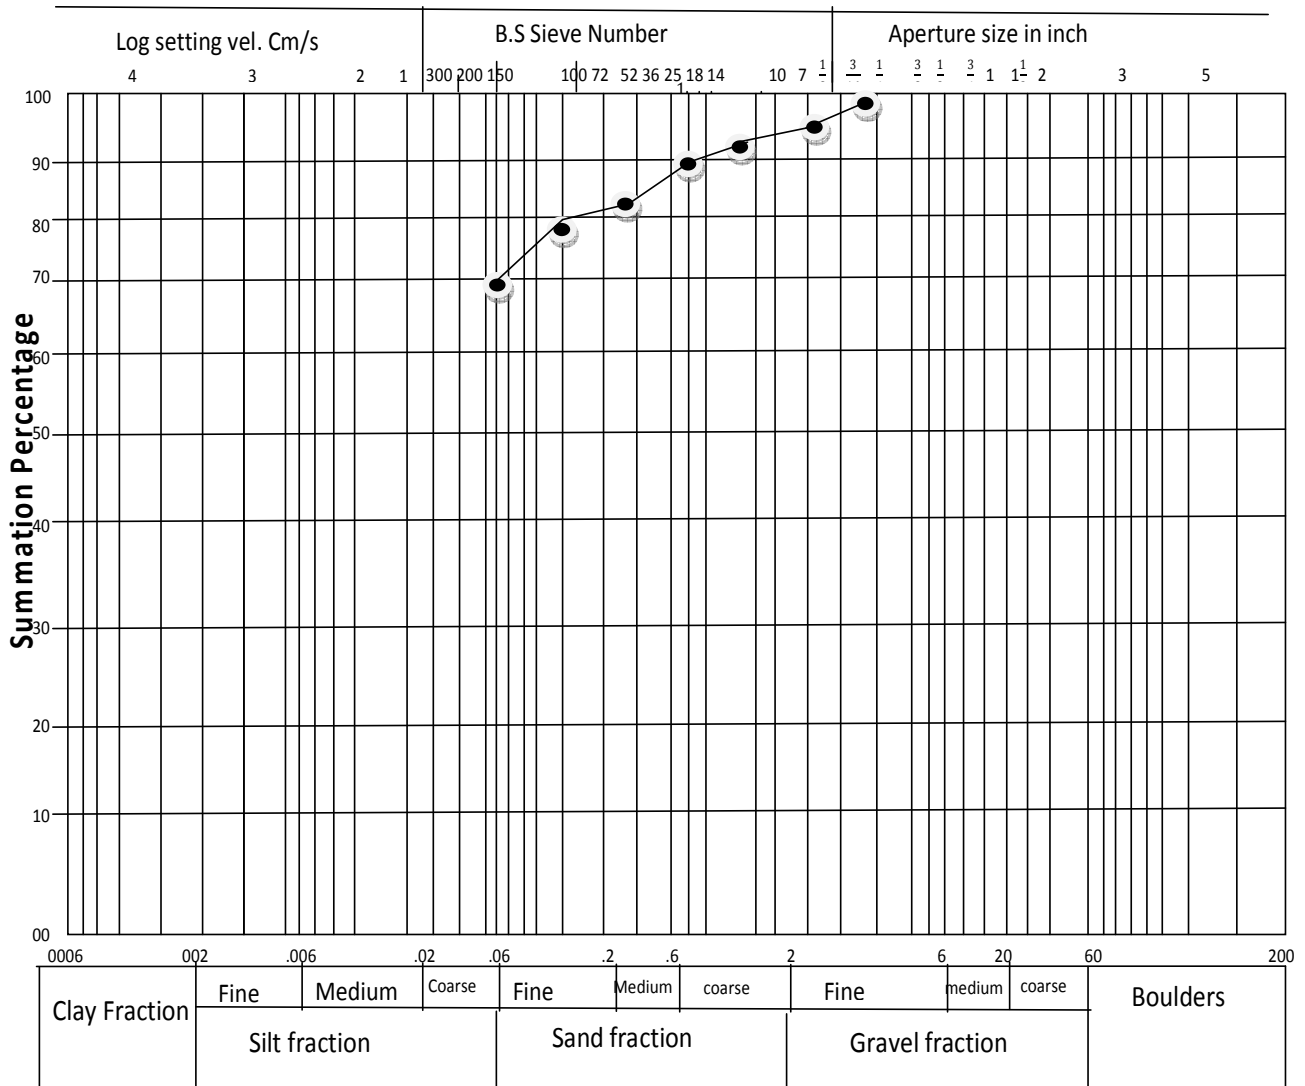
**Figure-16**  
**Plot of sieve analyses curve of Cham dam site**

**Sieve Analysis:** Table 8 which shows the result of sieve analyses conducted on samples collected from the proposed borrowed pits indicate high percentage of fines confirms relatively high plasticity obtained for the study area (figure 16). The results confirms cohesive non-friable soils.
