# Assessment of Channel Bank Susceptibility and Bank Stability of A Braided Reach of River Ganga Near Panchanandapur, Malda

**Rajib Tarani Das**

M.Phil Research Scholar, Department of Geography, University of Gour Banga, Malda-732103, India rajibtaranidas@gmail.com

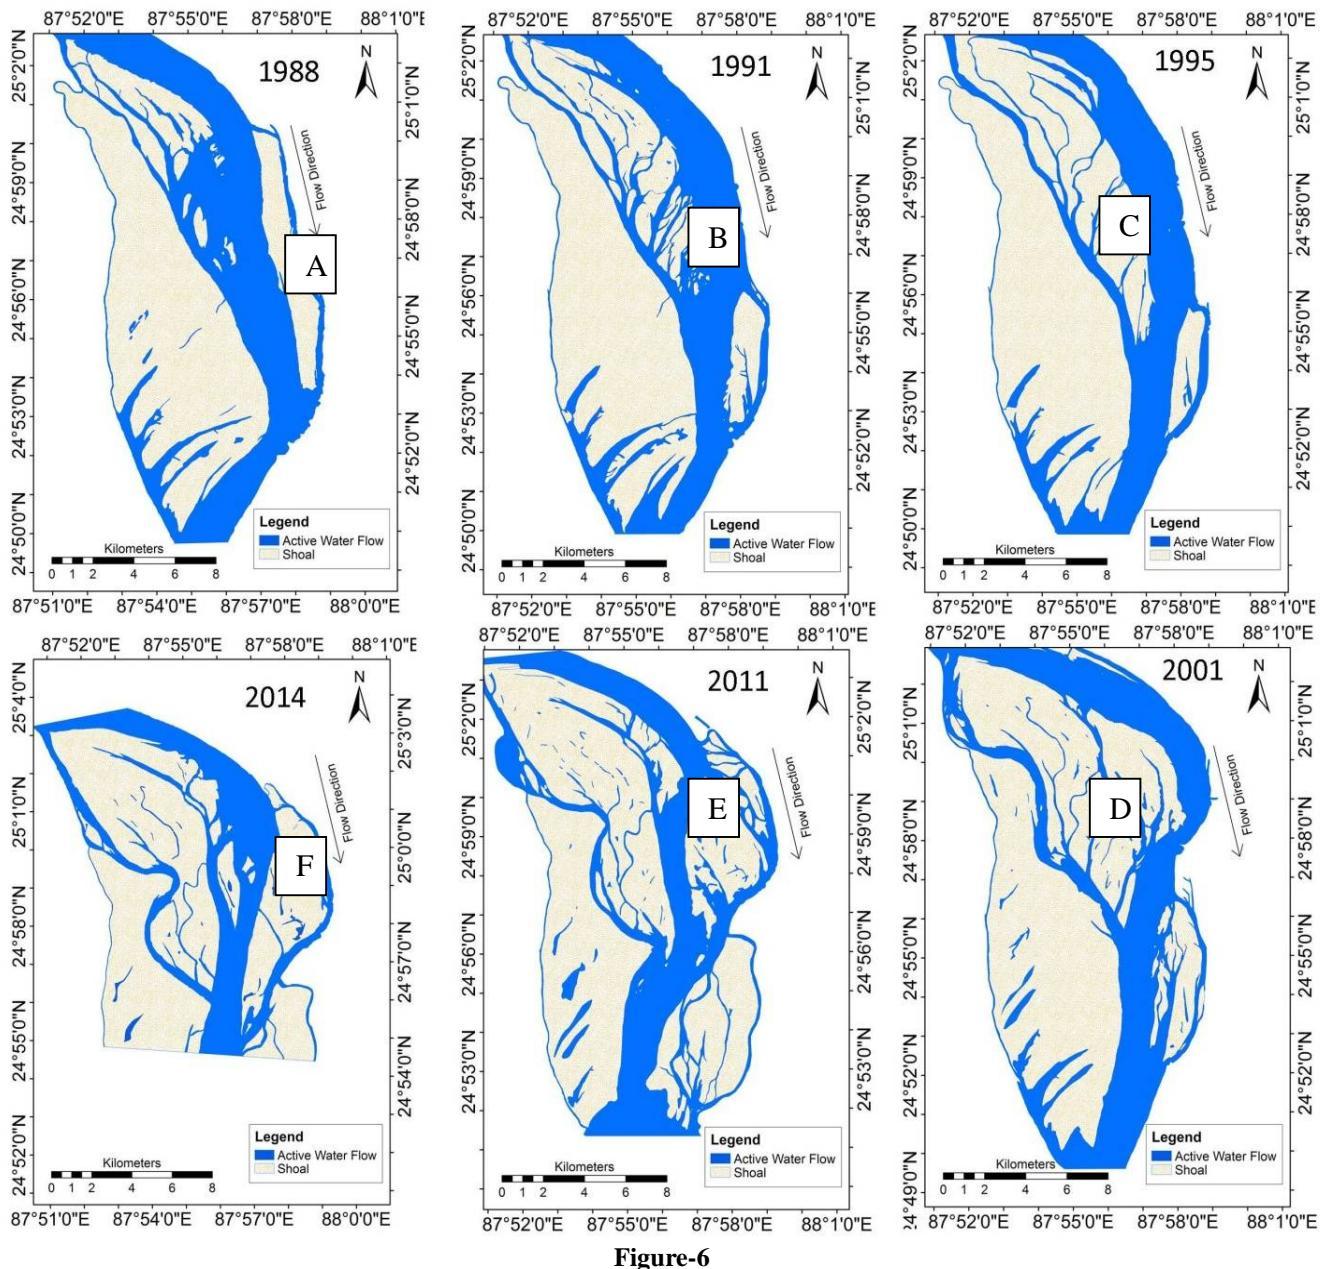
Active Flow Pattern of the reach in different time periods

In the study reach nature of flow and direction of flow path (active flow) have changed through passage of time. The main reason of shifting of flow path is the continuous changing position of braids and bars. Six maps of reach in different time period (map A-F) have been clearly showing (figure-6) the shifting of flow path and formation of new islands in the river. It has been seen from Figure-6 the map A (1988) that main flow of water was at the left side and one another narrow flow was at right side of the river. But in the map E (2011), there are some new bars formed at left side flow path and in the map D (2001) the braid which was at centre of the river continuously bifurcated widening mid channel flow path and left bank tending to reduce. Map E (2011) and F (2014) showing continuous shifting of bars towards the left bank and most of the water flowing through the middle portion of the river. Continuous deposition of sand bars on the left bank reducing erosion by direct flow.

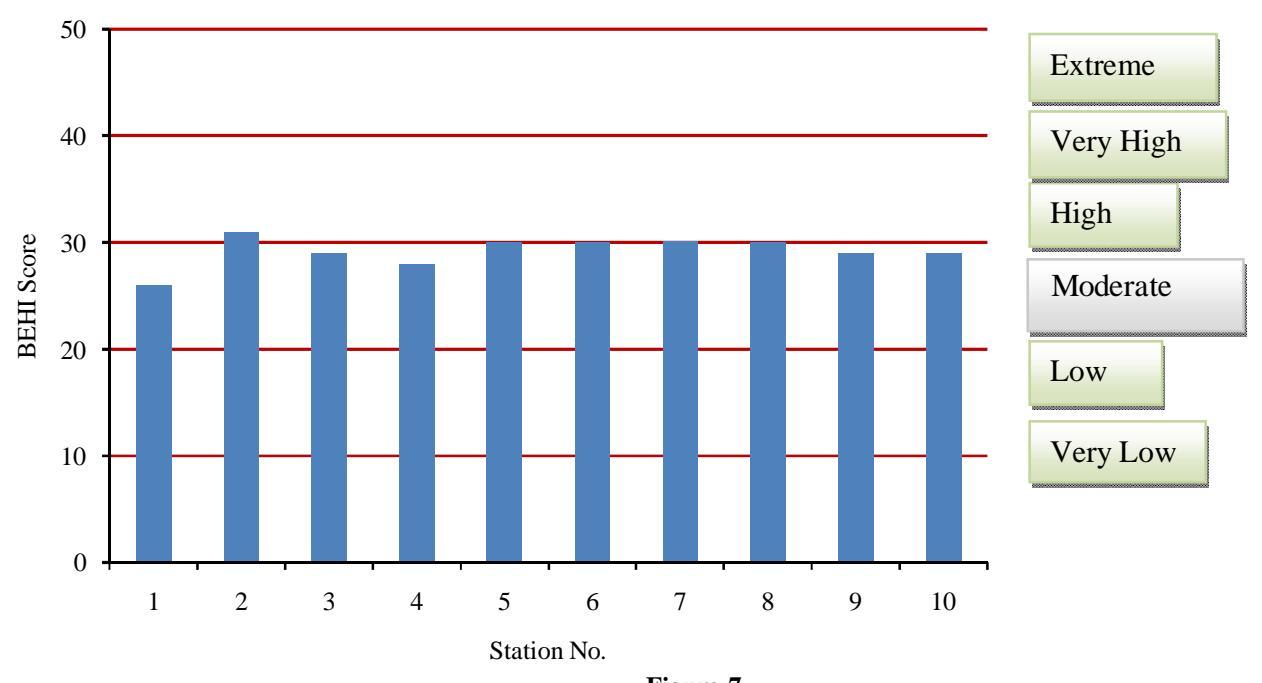
Figure-7 Selected BEHI Results along Left Bank of Ganga, Near Panchanandapur of Kaliachak-II Block

**Bank erosion Hazard Index (BEHI):** Bank erosion Hazard Index is calculated along ten selected sites based on previous said method (Table-8). Value of this index represents the study reach is moderate to highly erosion prone area. Out of ten stations, station no.2, 5, 6, 7 and 8 represent high category in BEHI rating Figure -7.

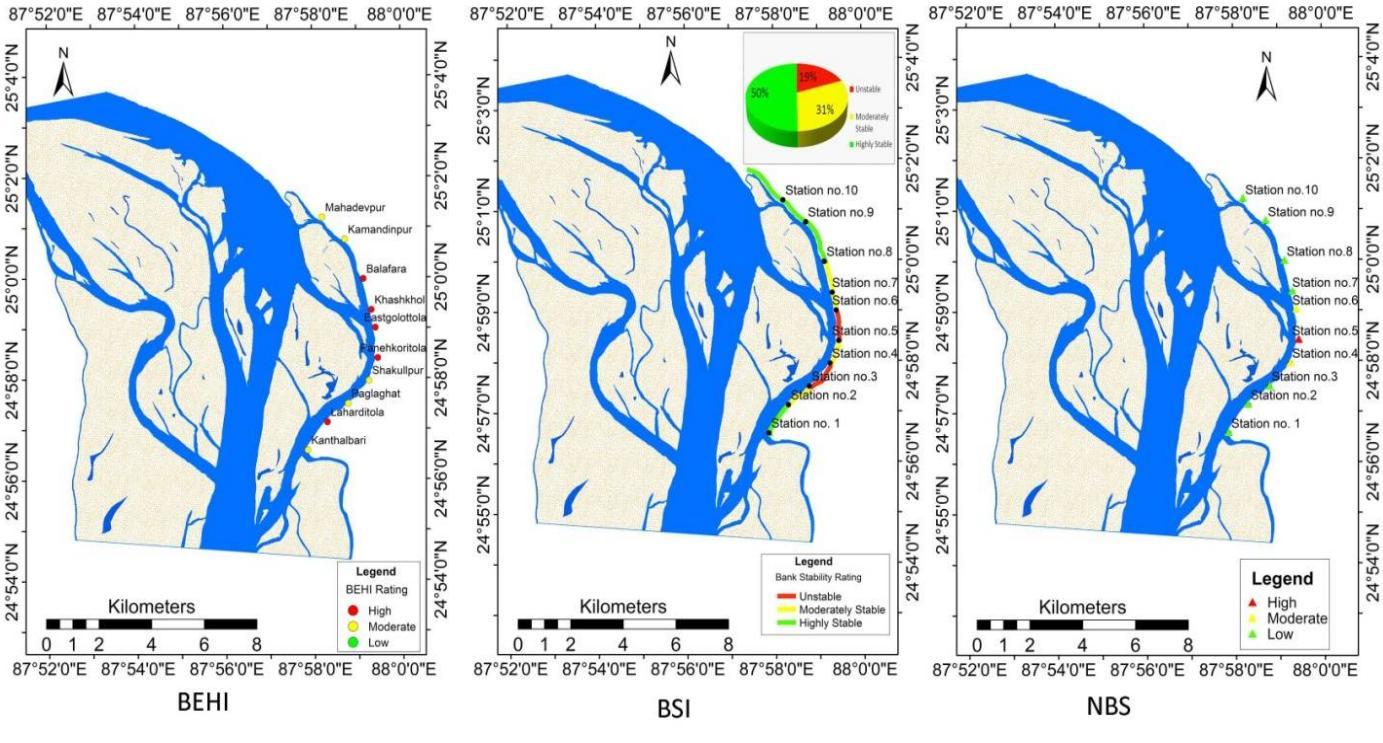
The result of comparative analysis of BEHI, NBS and BSI shows only station no.5 relatively unstable, high bank erosion prone and there is high near bank stress (Figure-10).

Figure-10 Comparative analysis of BEHI, NBS and BSI

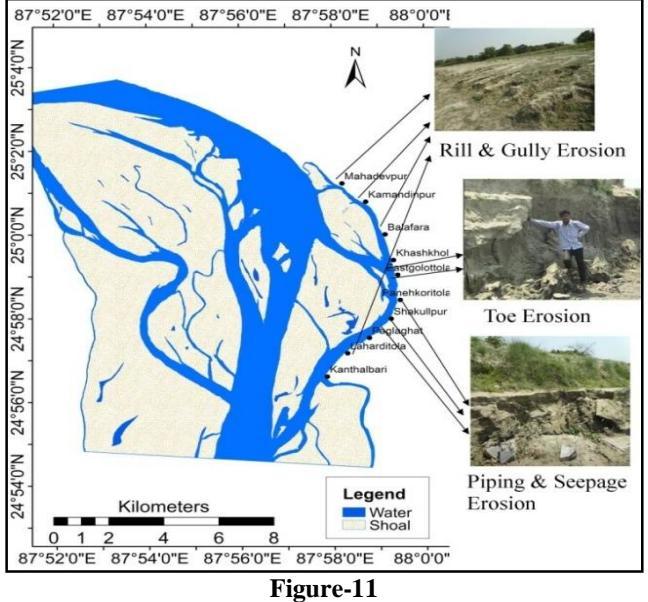
Dominant erosional processes of the reach

**Erosional Mechanisms and Processes:** Though actual Erosional process is the combination of several Erosional mechanism but three dominant Erosional mechanisms (rilland gully, toe erosion, seepage and piping) have been identified in the study area (figure-11). Among various erosional mechanism toe erosion and gully erosion are main Erosional processes in this area.

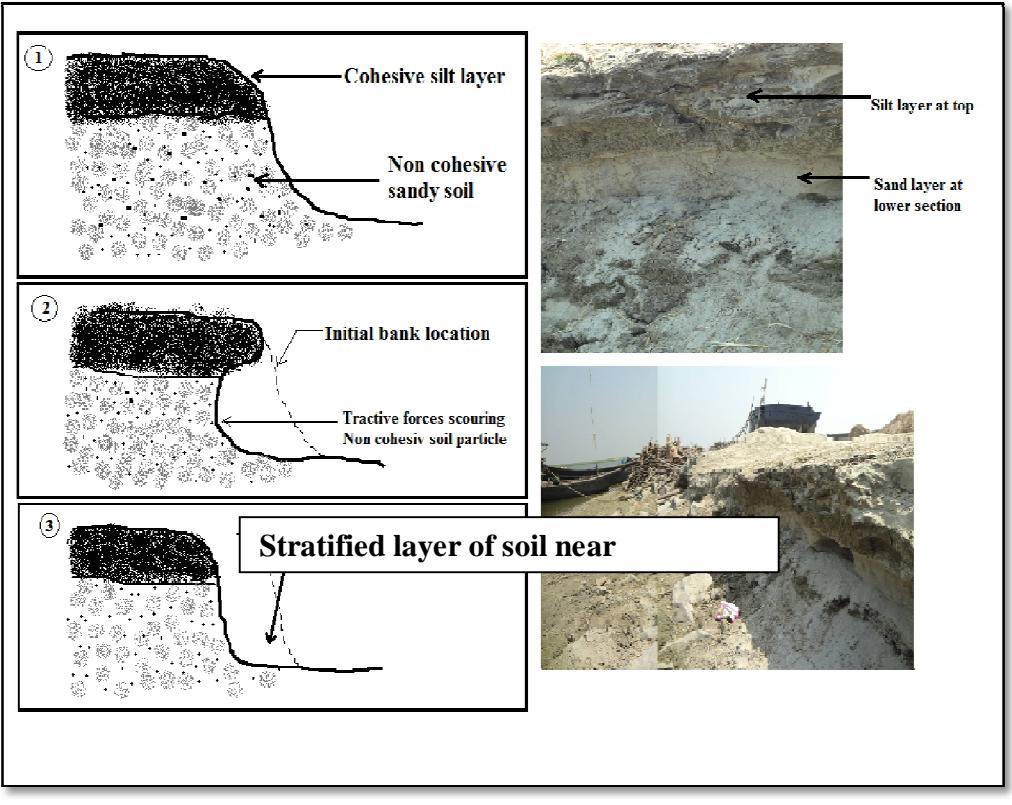
Another natural reason of soil erosion in this area is stratified layer of soil. The bank of the reach is formed with alternate layers of silt (Fine), clay and sand (Figure-12). These soils consist of layers of materials of various textures, permeability, and cohesion. When cohesion less layers are interbedded with cohesive soils, the erosion potential is determined by the characteristics of the cohesion less soil. In the study area cohesion less sand layer is overlaying by silt and clay layer which is more prone to toe erosion.

Figure-12 Erosional processes in a stratified layer of soil

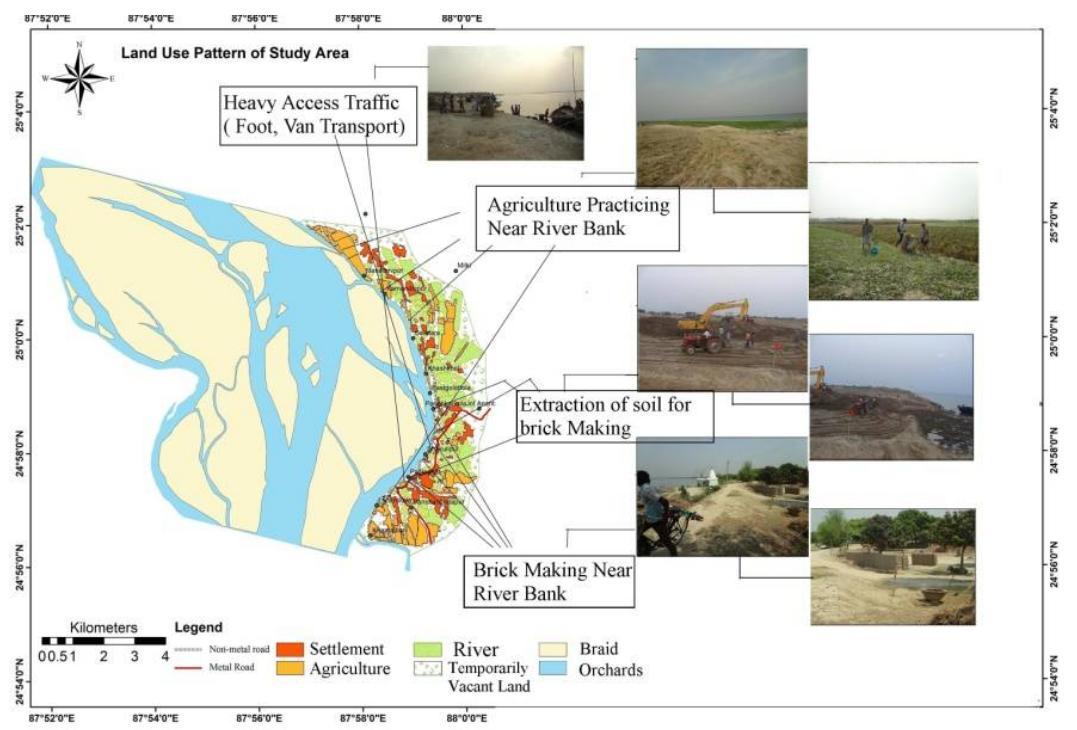
**Man Induced Causes:** Human activities are also responsible for river bank erosion. Human is an active agent which brings about modification of natural landscape. This modification sometimes accelerates bank erosion. In the study area river bank erosion is also cause of some human activities such as – heavy access traffic, excess agricultural activities near bank of the river and excess soil extraction for brick making (Figure-13).

Figure-13 Relationship of land use pattern erosional processes of the reach
