Intentionally setting fire to JCB excavator for fraudulent insurance claim

Abstract

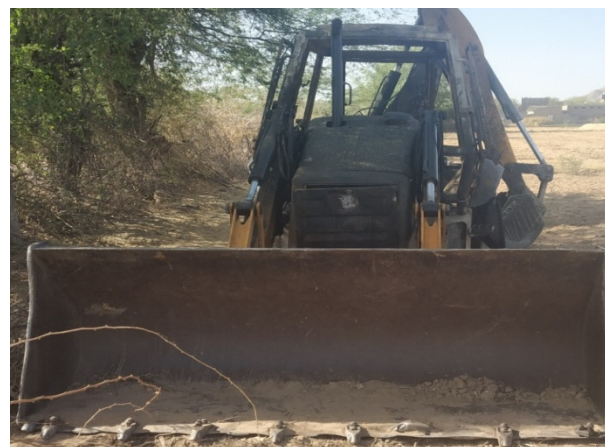
Figure-1: A front view of burnt JCB.

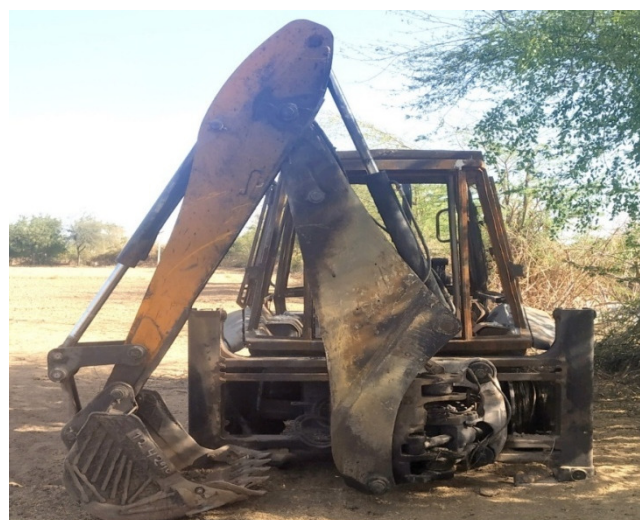
Figure-2: A backside view of the JCB.

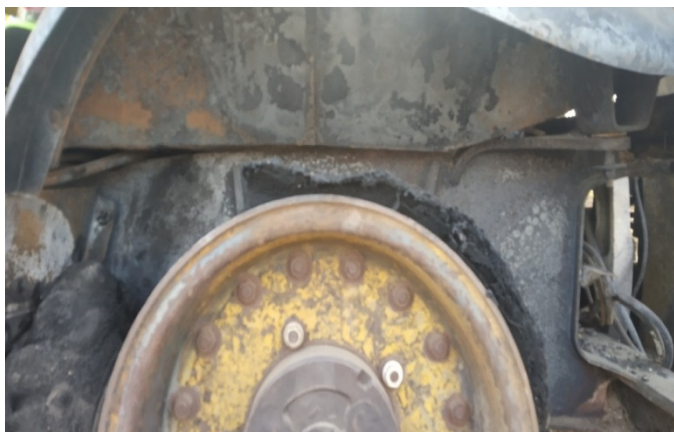
Figure-3: A close up view of the left rear tire upper central portion.

According to the driver, he first noticed fire in the central upper portion of left rear tire. A detailed examination of that area did not reveal any cause for the fire to originate at that spot. There was no satisfactory answer from the driver when asked the reason for the fire to originate at the spot. Further it was found that the right two tires of the JCB were totally burnt whereas the left two tires were partially burnt. This was contrary to what was expected, had the fire originated from the left side of the JCB.

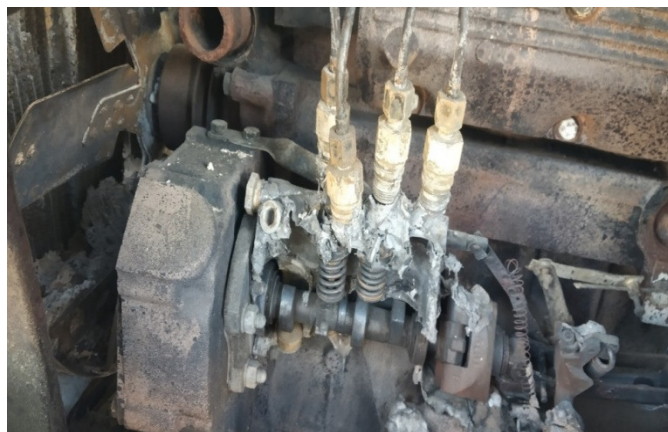
Figure-6: A view of the burnt engine.

The possibility of any electrical short circuit in any of the engine electrical wiring system or the battery mechanism was ruled out because such short circuit leading to fire could not have caused intense burn effects including the burning of the metallic doors and bonnet as observed in the instant case within a short period. A thorough examination of the burnt wires coming from the battery did not reveal any formation of beading, further ruling out the possibility of short circuit being the cause of fire.

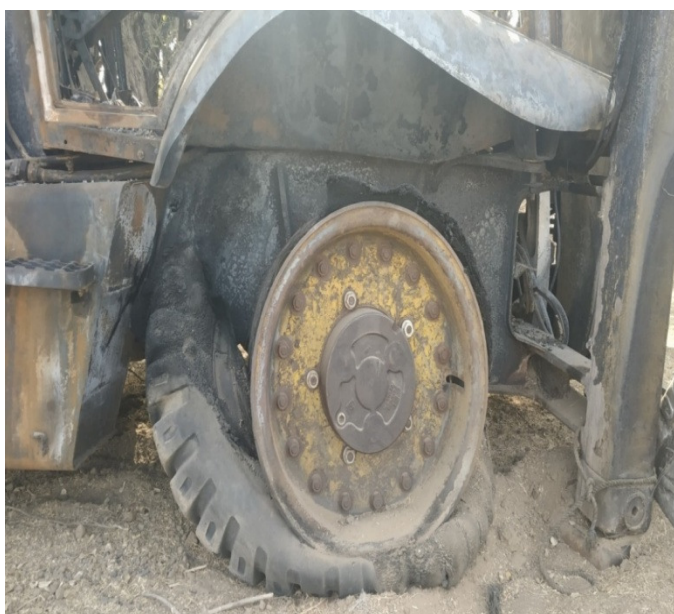
Figure-4: A view of left front tire.

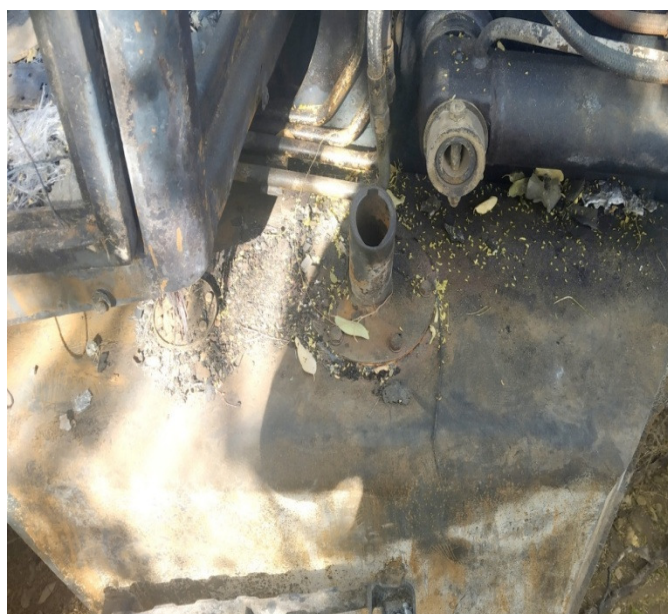
Figure-7: Diesel tank unaffected by fire.

The cause of fire due to rupture of the fuel tank producing hazardous spill was ruled out as the fuel tank was totally intact.

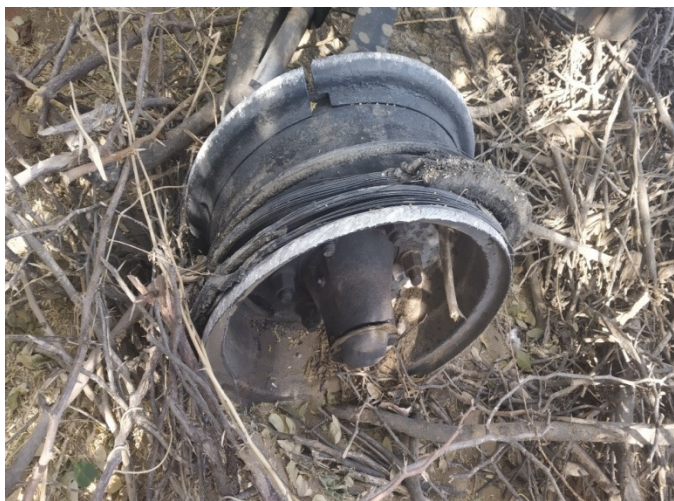
Figure-5: A view of completely burnt right rear tire.

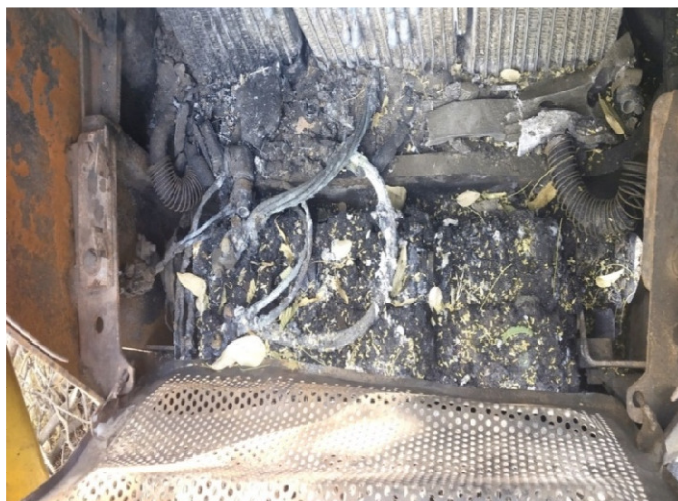
Figure-8: A view of burnt battery.

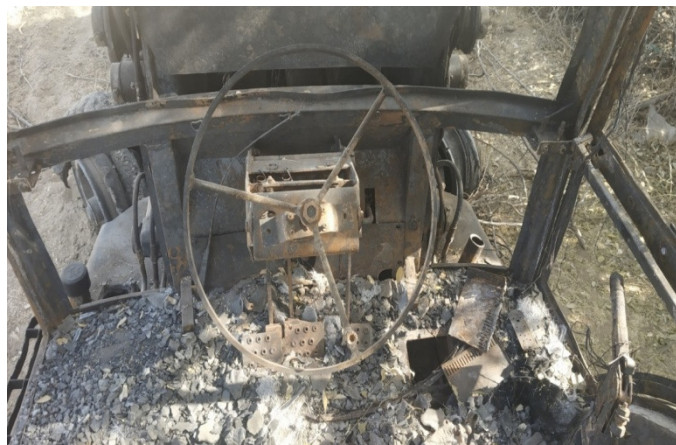
All the flammables inside the cabin of JCB such as seat covers, rubber mats etc., were totally burnt. Also the dash board, steering wheel and other fittings in the dashboard were totally burnt.

Figure-9: A view of completely burnt cabin, steering wheel etc.

Taking into consideration the burn patterns in the cabin and around the body as well as in the engine compartment lead to a conclusion that the vehicle suffered intense heat and fire effects only an account of deliberate and planned attempt.
