# Construction challenges during tunnelling underneath the Mithi river, Mumbai, India

*Tunnelling underneath the water body is the most challenging part of the underground project and requires specific study, design, monitoring, and highly skilled professionals that can complete the task with the help of modern and innovative engineering. This paper tried to cover construction challenges faced during the tunnelling underneath the Mithi river at Mumbai Underground Metro Line -3 twin tube, 5.50 m finished diameter (Colaba- Bandra- Seepz) including 152 m NATM tunnel and 4 nos. of cross-passages, which made project more precious and challenging. Apart from tunnelling underneath the river, tunnel alignment was curved also and TBM mining becomes more challenging. In this case study, will discuss the challenges from the geological investigation to the construction of TBM tunnelling, NATM tunnel and cross passage (CP) underneath the Mithi river. As the overburden thickness from the river bed to the tunnel crown portion was about 5 m with weathered basaltic breccia rock; challenges were complete the geological investigation, water seepage, tunnel segment design, tunnel alignment deflection

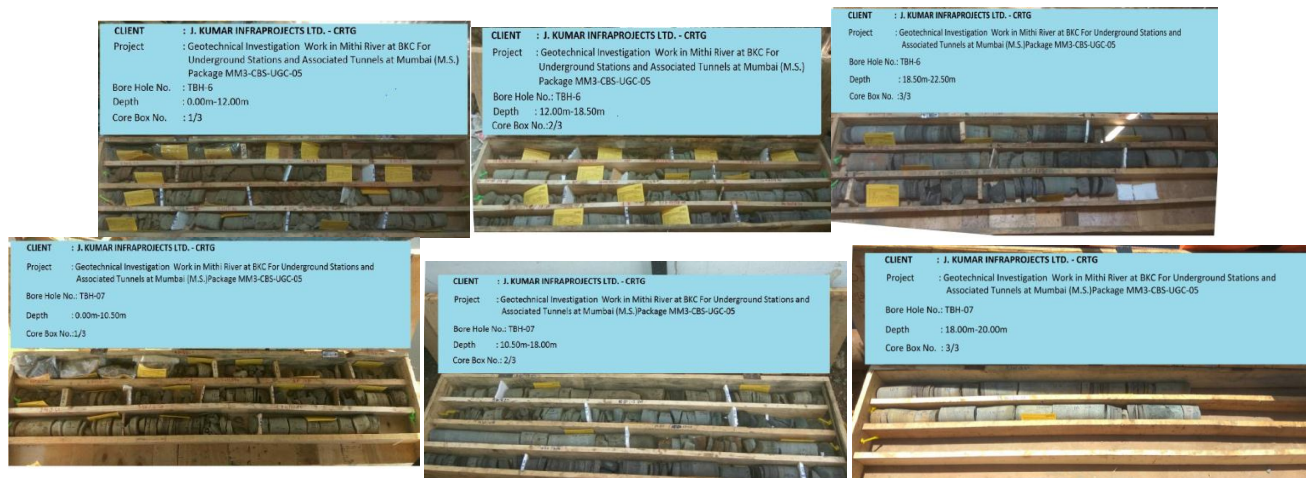
Figure-5: Core recovery underneath the Mithi river during a geological investigation<sup>8</sup>.

During the site geological investigation stage, only three boreholes were possible along the Mithi river tunnel alignment. The core recovery was very poor. As rock condition was very poor belongs to grades IV and V and bedrock alignment varies drastically as shown in the geological section given in Figure-4 and core boxes photographs shown in Figure-5.

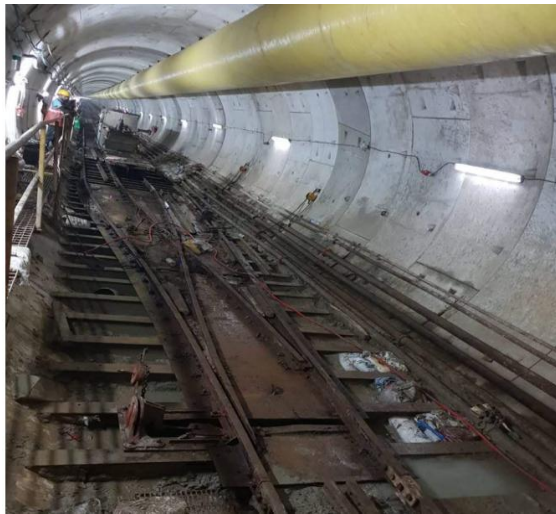
Figure-9: California Crossing.

passage. Cross-passage segment location and section of a cross-passage are shown in Figure-7 and Figure-8. California crossing was also there in the TBM tunnel as shown in Figure-9.

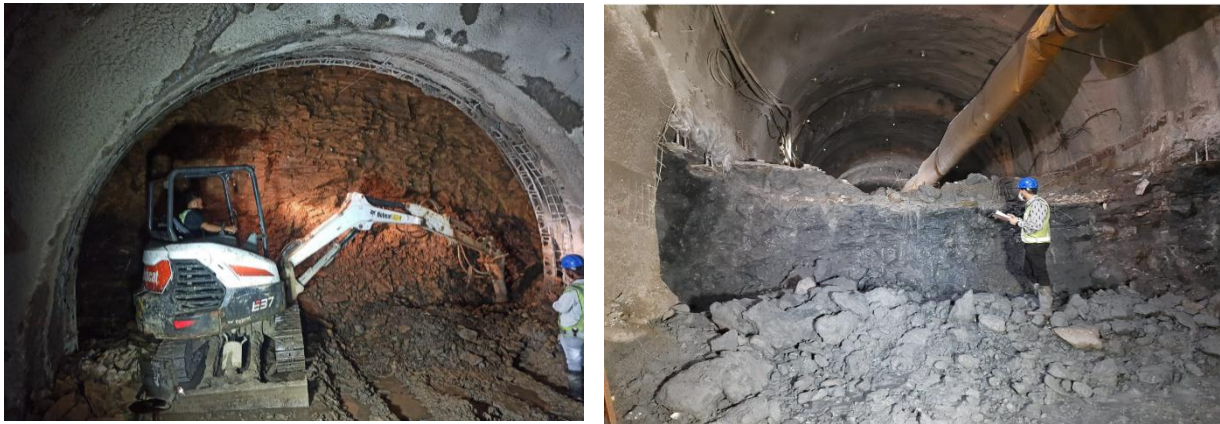
Figure-12: Heading and benching excavation under BKC south NATM tunnel.

As the rock belongs to grade IV to lower grade III, heading and benching NATM methods were applied, sequence of excavation is discussed below and the cross section and site photos are given in Figure-11 and 12 respectively:

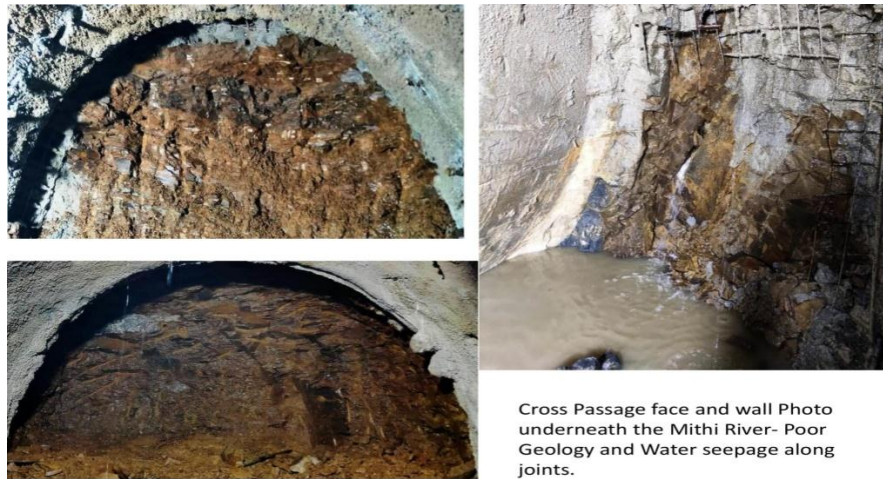
Cross Passage face and wall Photo underneath the Mithi River- Poor Geology and Water seepage along joints.

Figure-13: Rock face and water seepage during construction of cross-passage underneath the Mithi river.

**Other construction challengers:** Apart from high precautionary measures taken, the following construction challenges were faced by the construction team: i. During TBM mining, the tunnel team faced high water discharge (20-30 liter/per minute) during the segment building. Dewatering and removal of sludge was an issue but due to team hard work and good management of muck removal team, achieved average progress of 10 m mining per day. ii. Due to poor and variable geological strata with water ingress, maintaining the tunnel face pressure was an issue. iii. High quantity of primary and secondary grout also was a concern. iv. During the construction of the cross passage, grade III and IV volcanic breccia rock was encountered with an average RMR varies between 35-55 water seepage was an issue and well managed by the team. The site photo is given in Figure-13.

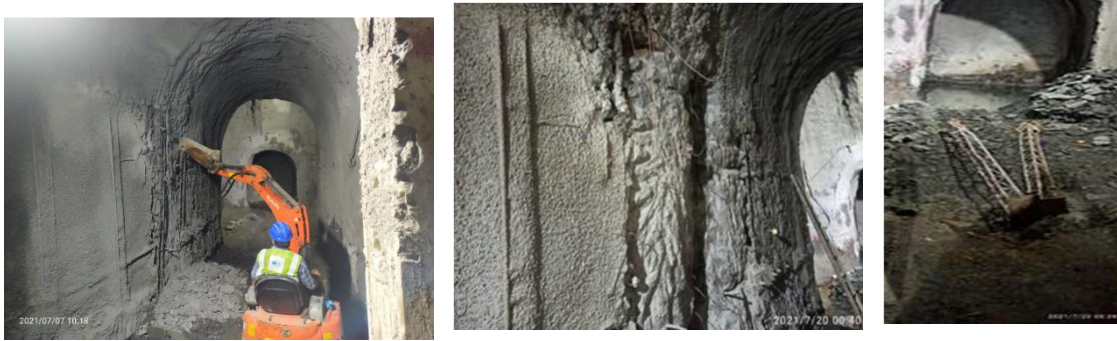
Figure-14: Repair of undercutting work.

**Cross passage –Undercutting and overcutting in excavation work:** During excavation centre line alignment of the main NATM and cross passages was maintained properly. In one of the cross passages, CP- 05 which was connecting the south side turn back NATM tunnel and TBM tunnel, excavation and temporary lining work was started at both ends of the cross passage and there was some deviation happened in alignment. It

was observed after the completion of temporary lining work that there was an undercut on one side of the wall face. The new scheme was prepared for dismantling and maintaining the correct alignment.

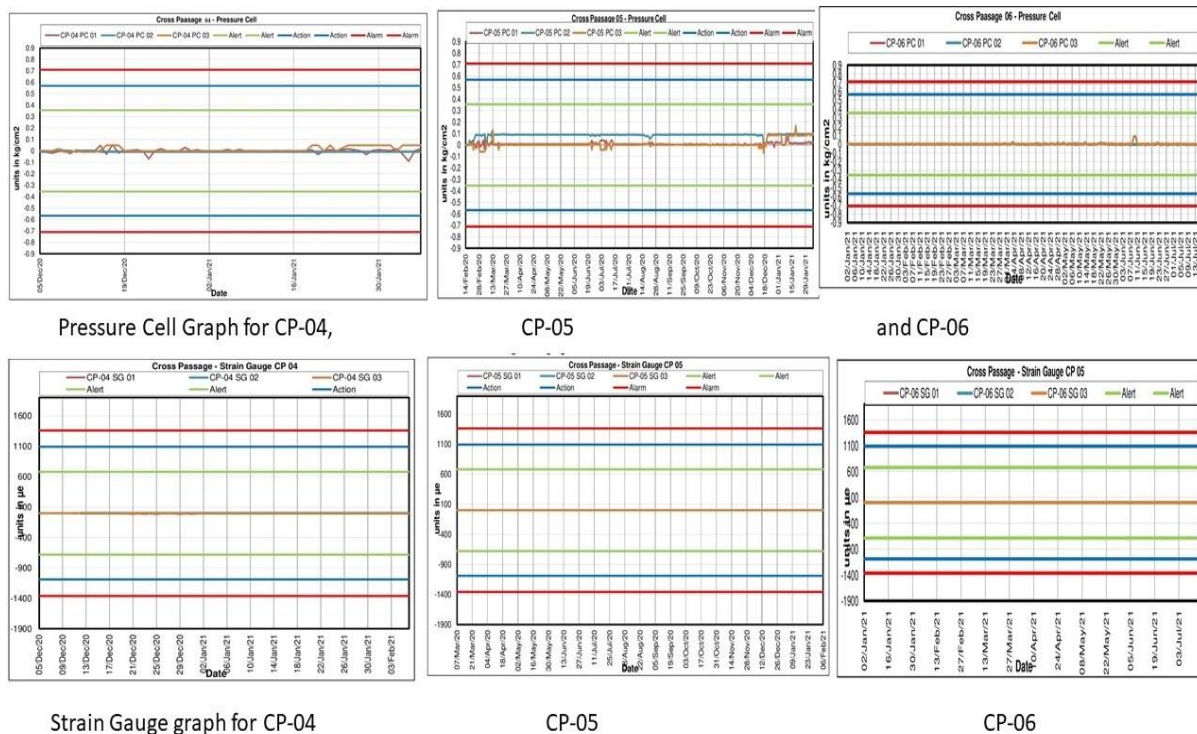
Figure-18: Instrumentation reading graph<sup>11</sup>.

All instrumentation readings were under control due to safe mining practices and competent rock mass. The instrumentation

reading graph is given below for reference Figure-18; where no deflection was observed.

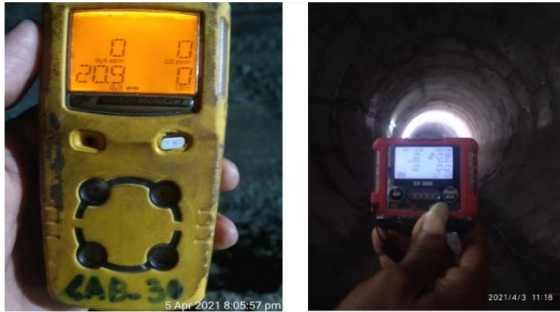
Figure-19: Air quality measurement inside the tunnel.

**Safety and environmental aspect:** i. Emergency preparation plan- This plan includes all emergency procedures followed at the time of emergency. ii. Fire hydrant system: Proper fire hydrant system<sup>12</sup> has been implemented in the tunnel. iii. Proper access and egress were maintained for tunnel operation. iv. Signage – Proper signage has been displayed for the hazardous operation. v. Air quality monitoring–Measurement of hazardous gases was done through a portable gas meter which measures the level of oxygen (O<sub>2</sub>), hydrogen sulphide (H<sub>2</sub>S), methane (CH<sub>4</sub>), carbon monoxide (CO), vi. Ventilation–Proper ventilation (fresh air) circulated.
