Review Paper

Geological Investigation of 5.6 M_w Mirpur Earthquake, Northwestern Himalayas, Pakistan

Keywords: Mirpur earthquake, Western Himalaya, Surface Rupture, Seismo-tectonics, Samwal Fault.

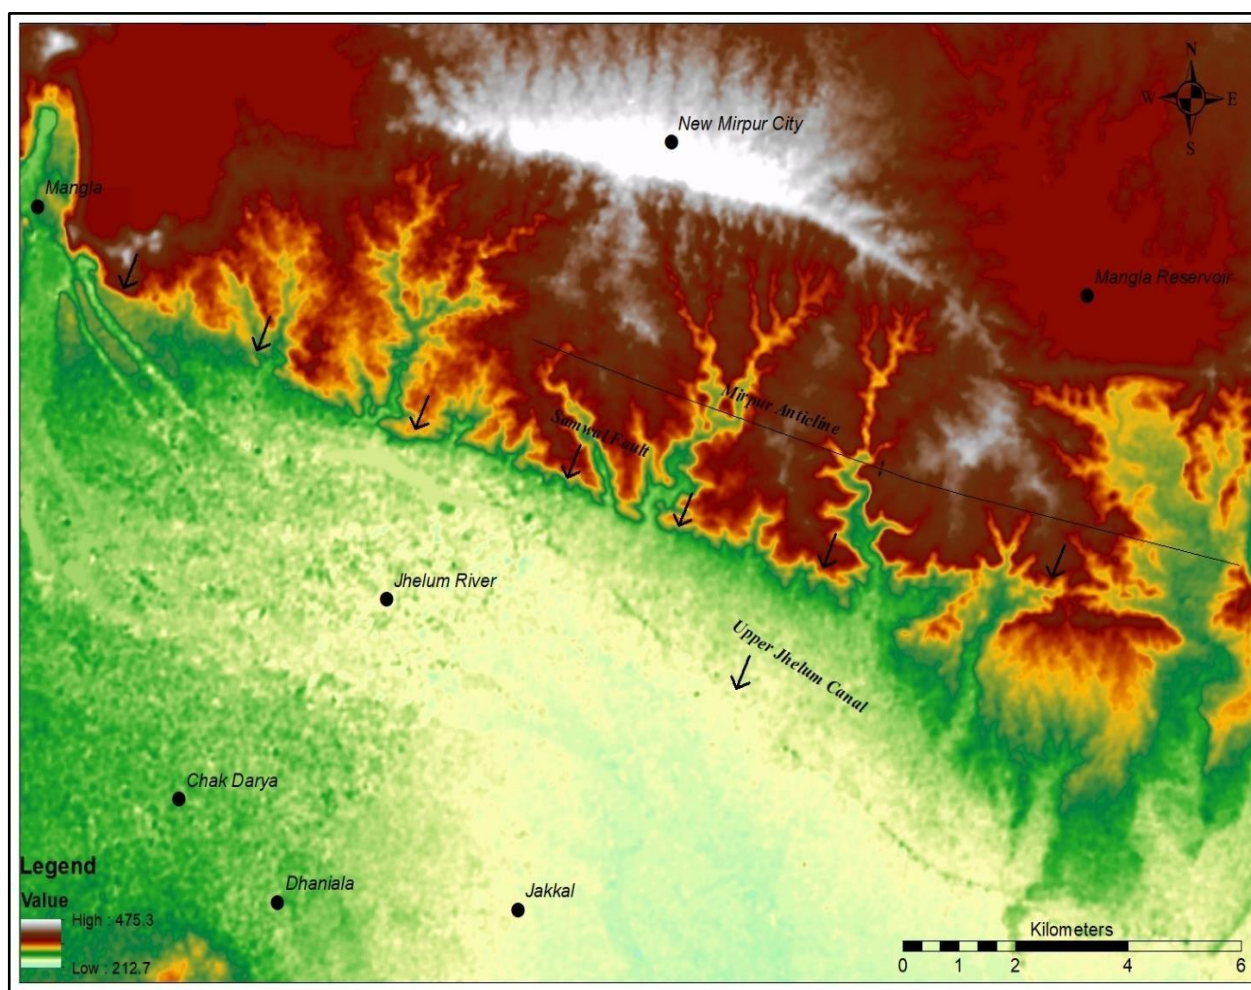
Faulting characteristics and surface deformation: The SF, a major NW-SE trending structure in the study area is likely the source of ME 2019. It lies approximately 5km south of the Mirpur City and forming a major topographic front in the area (Figure-5 and Figure-6). Field observations and geological studies suggested that the SF is a high angle dip-slip fault ranging from 45° to 85° NE. It emplaces the Dhok Pathan Formation of Miocene over the lower part of Soan Formation at places. At the eastern end of SF, the rocks were overturned and forming an overturned syncline with in the upper part of Soan Formation in the hanging wall, whereas, rocks were dipping normally (NE) at the western portion. The So an formation (600 m) and Recent deposits lies in the footwall of SF (Figure-1), which includes sheared rock with brittle deformation and drag folds. The brittle deformation includes breccias and gouge. The drag folds show sense of shear along fault that present at the base of hanging wall block show southwest directed thrusting along SF. The longitudinal extent (exposed) of SF is about 20 km, starting from Jari Kass in the east to the Mangla Colony in the west (Figure-6).

Figure-5: Digital elevation model (DEM)²⁷, illustrating major topographic front in the study area delineating the Samwal Fault (shown by arrows).

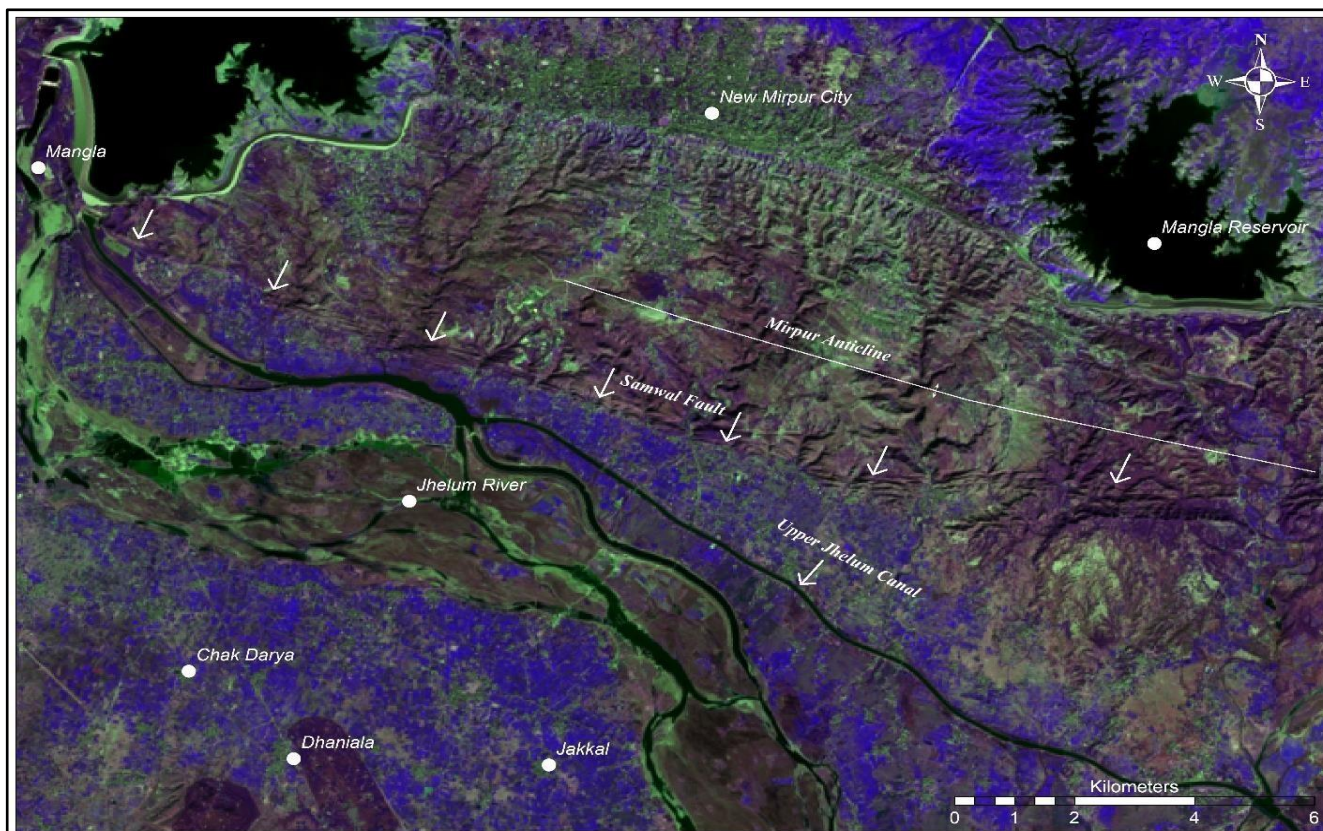
The identification of structural geometries and their kinematics portray an important aspect for evaluating structural development of any region. The surface manifestation is the first indication that signifies the structural changes⁸. The existence of manifestations, correlated with their faults beneath the surface. Faultzone was delineated based on morphological peculiarities and straightness on the satellite imagery. In this research, study of remote sensing for fault analysis has been done by utilizing Landsat-8 imagery²⁶ and Digital Elevation Models²⁷ that were processed digitally. The results of image analysis indicate there is one morphological straightness dominant direction of NW-SE (Figure-6).

Figure-6: Lands at imagery²⁶ after processing in GIS, showing the trace of fault in the study area.
