# Geophysical and Geotechnical Investigation of Cham Failed Dam Project, Ne Nigeria

Caleb Adwangashi Tabwassah and Gabriel Ike Obiefuna

Department of Geology Federal University of Technology, Yola, NIGERIA

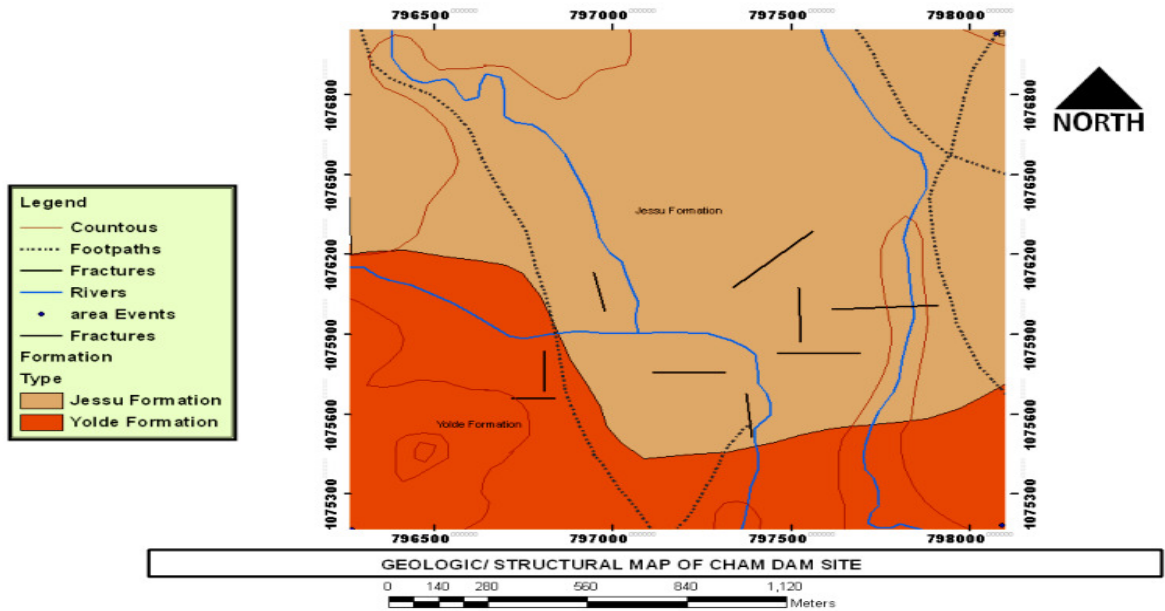
**Figure-1**  
 Geologic/Structural Map of Cham Dam Site

**Site Geology:** Yolde Formation: This Formation at the dam site is composed of a sequence of grayish/whitish and brownish shales, mudstone and occasional fine grained laminated sand in some areas within the dam site. These rocks were obscured by weathered shale which forms dark overburden clay (figure 1).

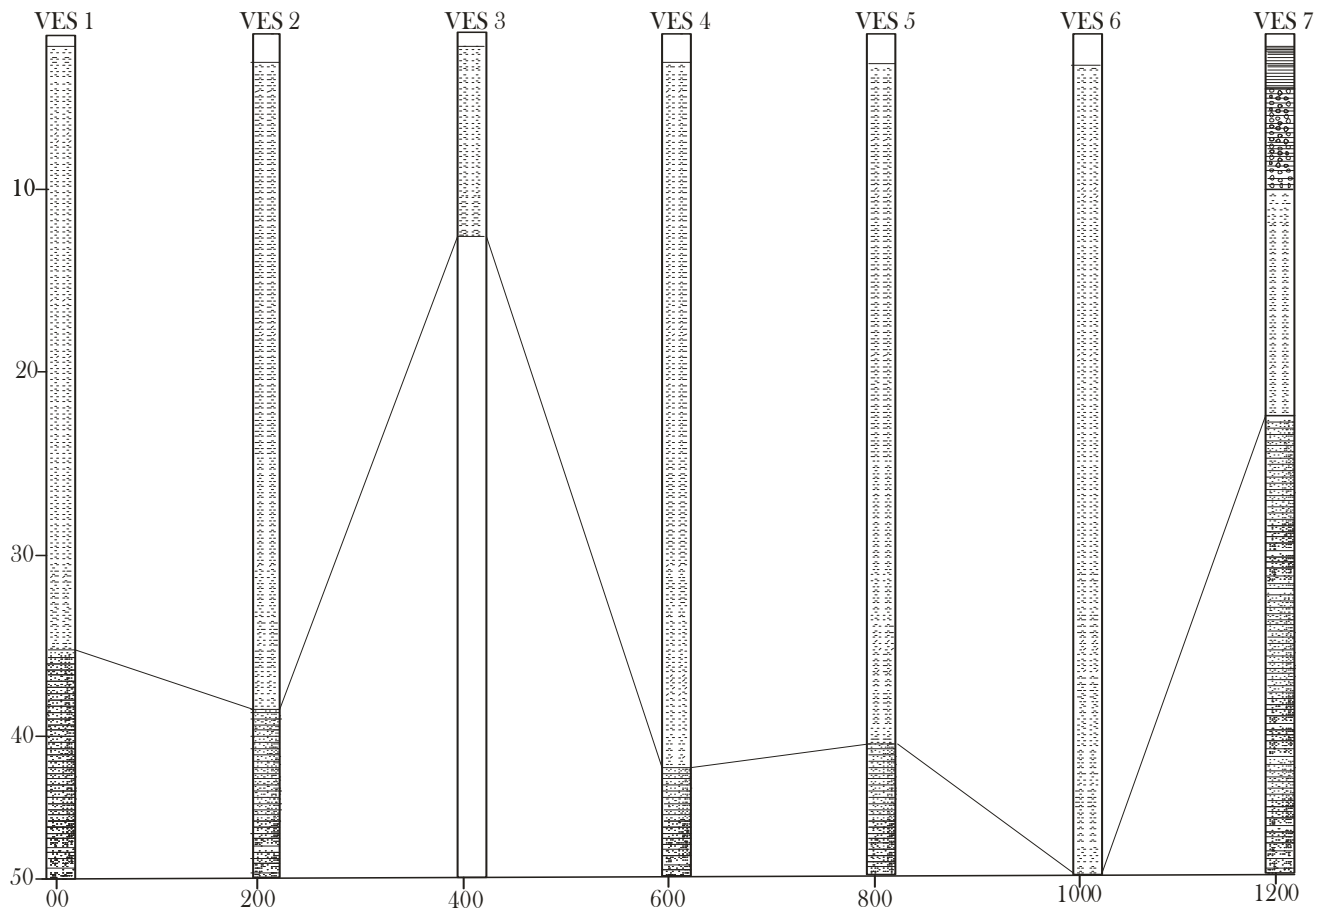
**Figure-2**  
 Exposed Lithologic Cross Section along a River Channel within Cham Dam

The above figure is an exposed cross-section of the underlying beds and structures along a river channel within the dam area, it could form an average representation of the studied area along the embankment. From the figure above, it could be deduced that, shally clay overlies siltstone to a depth of 35m at point 00, 39m at point 200m, 13m at point 600m, 45m at faults: These are also planar discontinuities observed along the floor of the reservoir area west ward and along the spillway (table 1). These result from offloading by

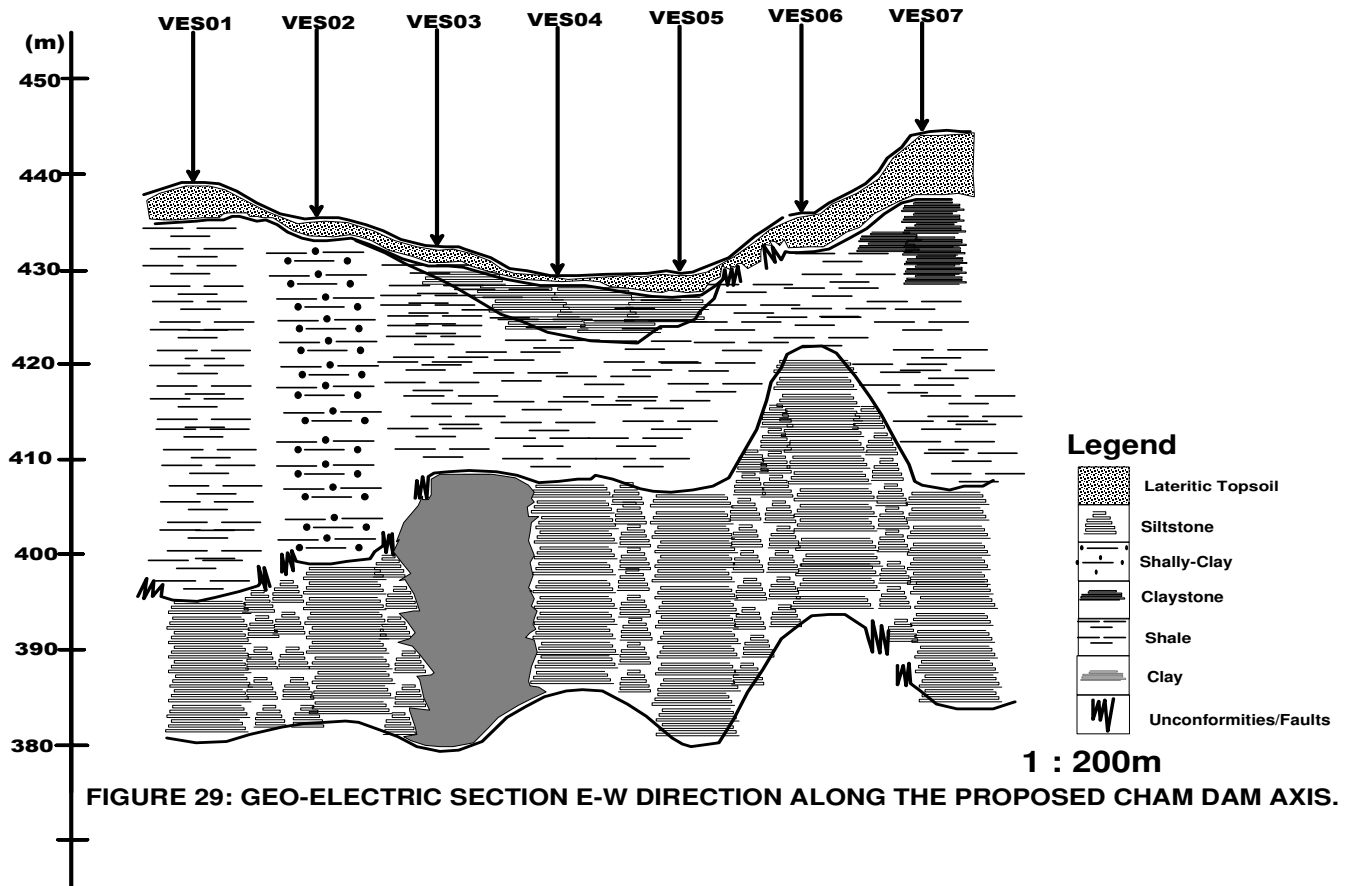
Figure-4  
 Geoelectrical section of proposed cham dam axis (subsurface layers)

From the above geo-electrical section of proposed cham dam axis, it is observed that the top lateritic soil is averagely 4m thick around VES 01 and approximately 8m at VES 07. This is immediately underlain by shale to shally clay at the depth of 4m from the topsoil and thickens averagely 40m along VES 01 – 03. At VES 03 – 05 is a patched bed of calcareous siltstone or marl, immediately underlying the topsoil at 11m depths to the center of the dam axis. The siltstone bed thins out at the east and western part of the dam axis.

**Major Displacements:** The major displacements are observed at depth 48m in VES 01, 45m at VES 02 and between VES 02 and 03 at 25m depth, others occurs between VES 06 and 07 at depth 53m down the subsurface. Table 2 is a summary of events on the geoelectrical section of proposed Cham dam axis.

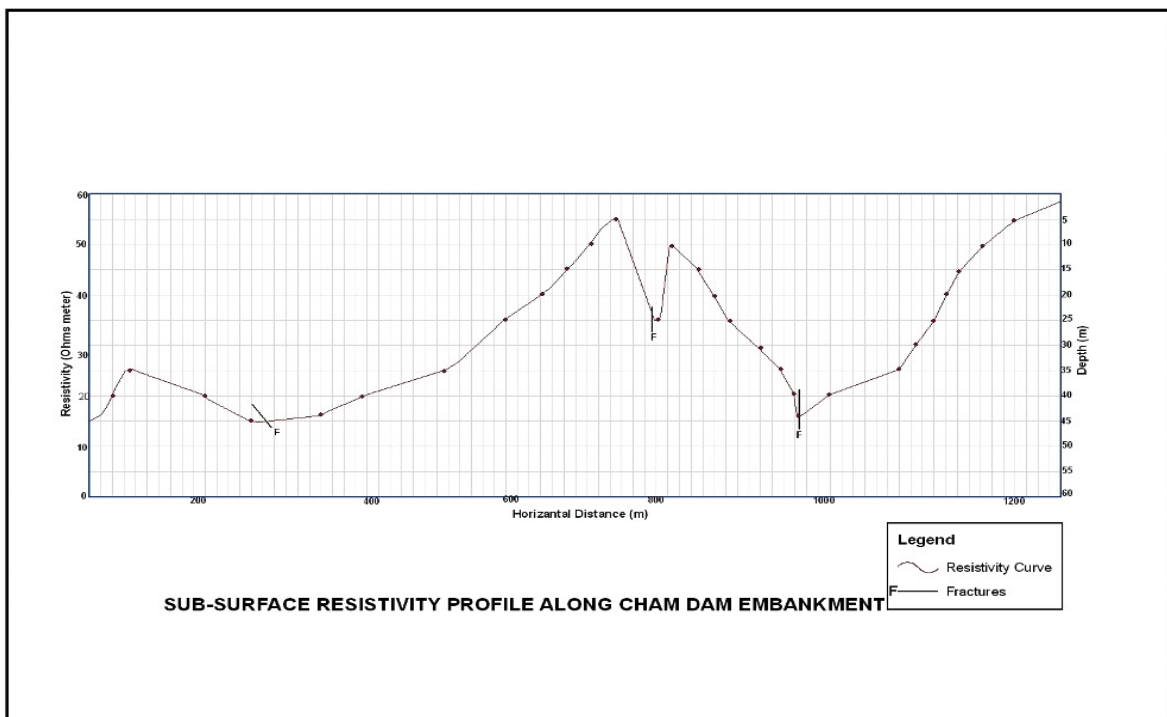
**Figure-6**  
Sub-Surface Resistivity Profile along Embankment

the resistivity contour map along Cham dam embankment and subsurface resistivity profile along dam embankment respectively. The resistivity contour map covers a total horizontal distance of about 1200m. The former shows the cross section of rocks along the embankment. The area is underlain by shally clay and top soil to an average depth of 35m, and a siltstone bed extend to an unknown depth around VES 1, this is approximately similar to those of VES 2 and 3, while VES 4, is an array of chronologic lateritic dark clay to friable shale which extend to about 35m (figures 7, 8, 9 and 10). This is immediately underlain by probable silty shale to muddy shale to an unknown depth below. VES 5 (800m) is characterized by abrupt high resistivity which indicates that siltstone out crops from about 50m to about 1.5m to the surface (figure 11). This point is characterized by abrupt fall in resistivity between the depths of 10-25m; this represents a probable displacement (fault).

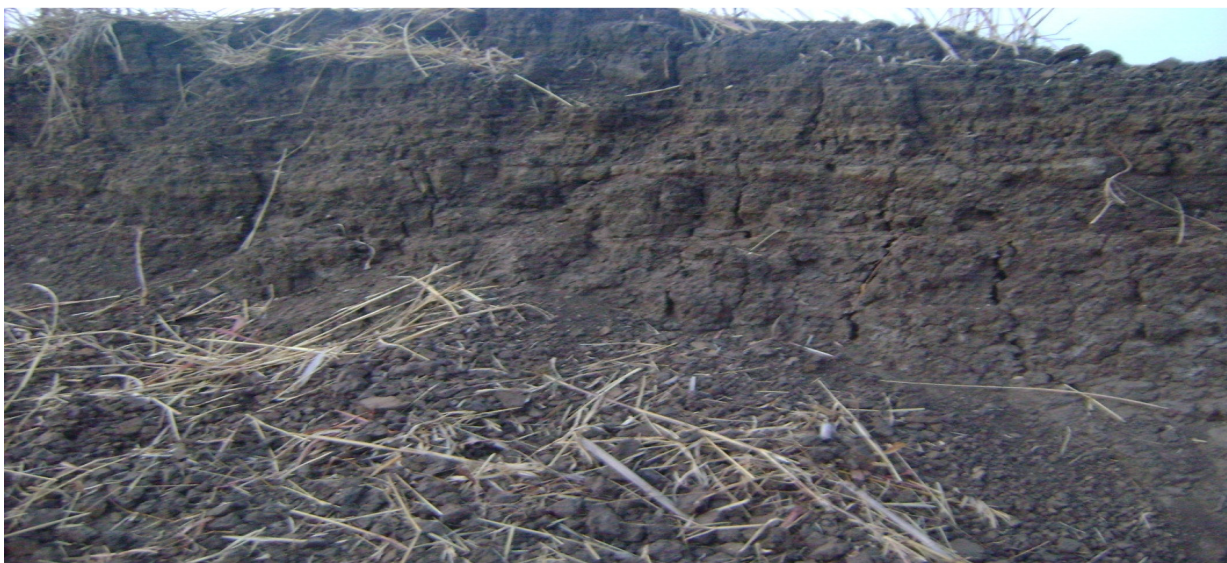
**Plate-1**

**Lithologic cross-section of rock type along Cham River around investigated area; it shows top lateritic clay overlying a clayey shale layer**

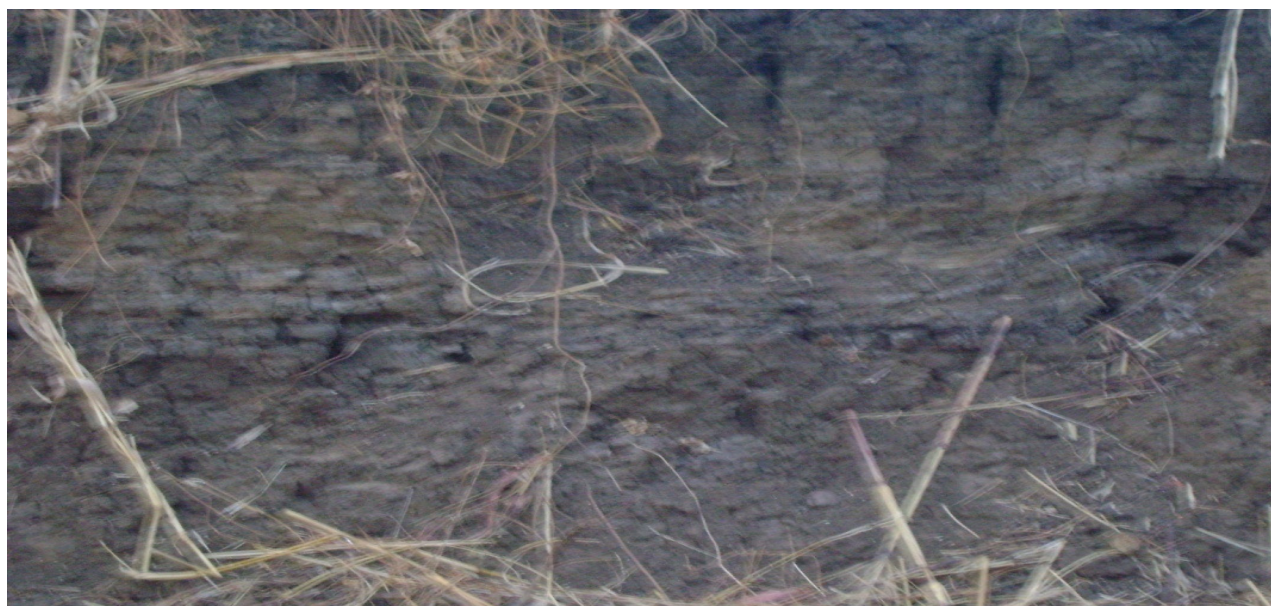
**Plate-2**

**Lithologic cross-section of rock type along Cham River around investigated area, it shows alternate layers of lateritic clayey shale and silt overlying massive clay or mudstone**
